# ABS Consulting

14 November 2011

Subject: *Cupples Station Building 7 Condition Assessment Review,  
1014 Spruce St. (Spruce & 11<sup>th</sup> St.), St. Louis, Missouri*

ABS Project: 2675837

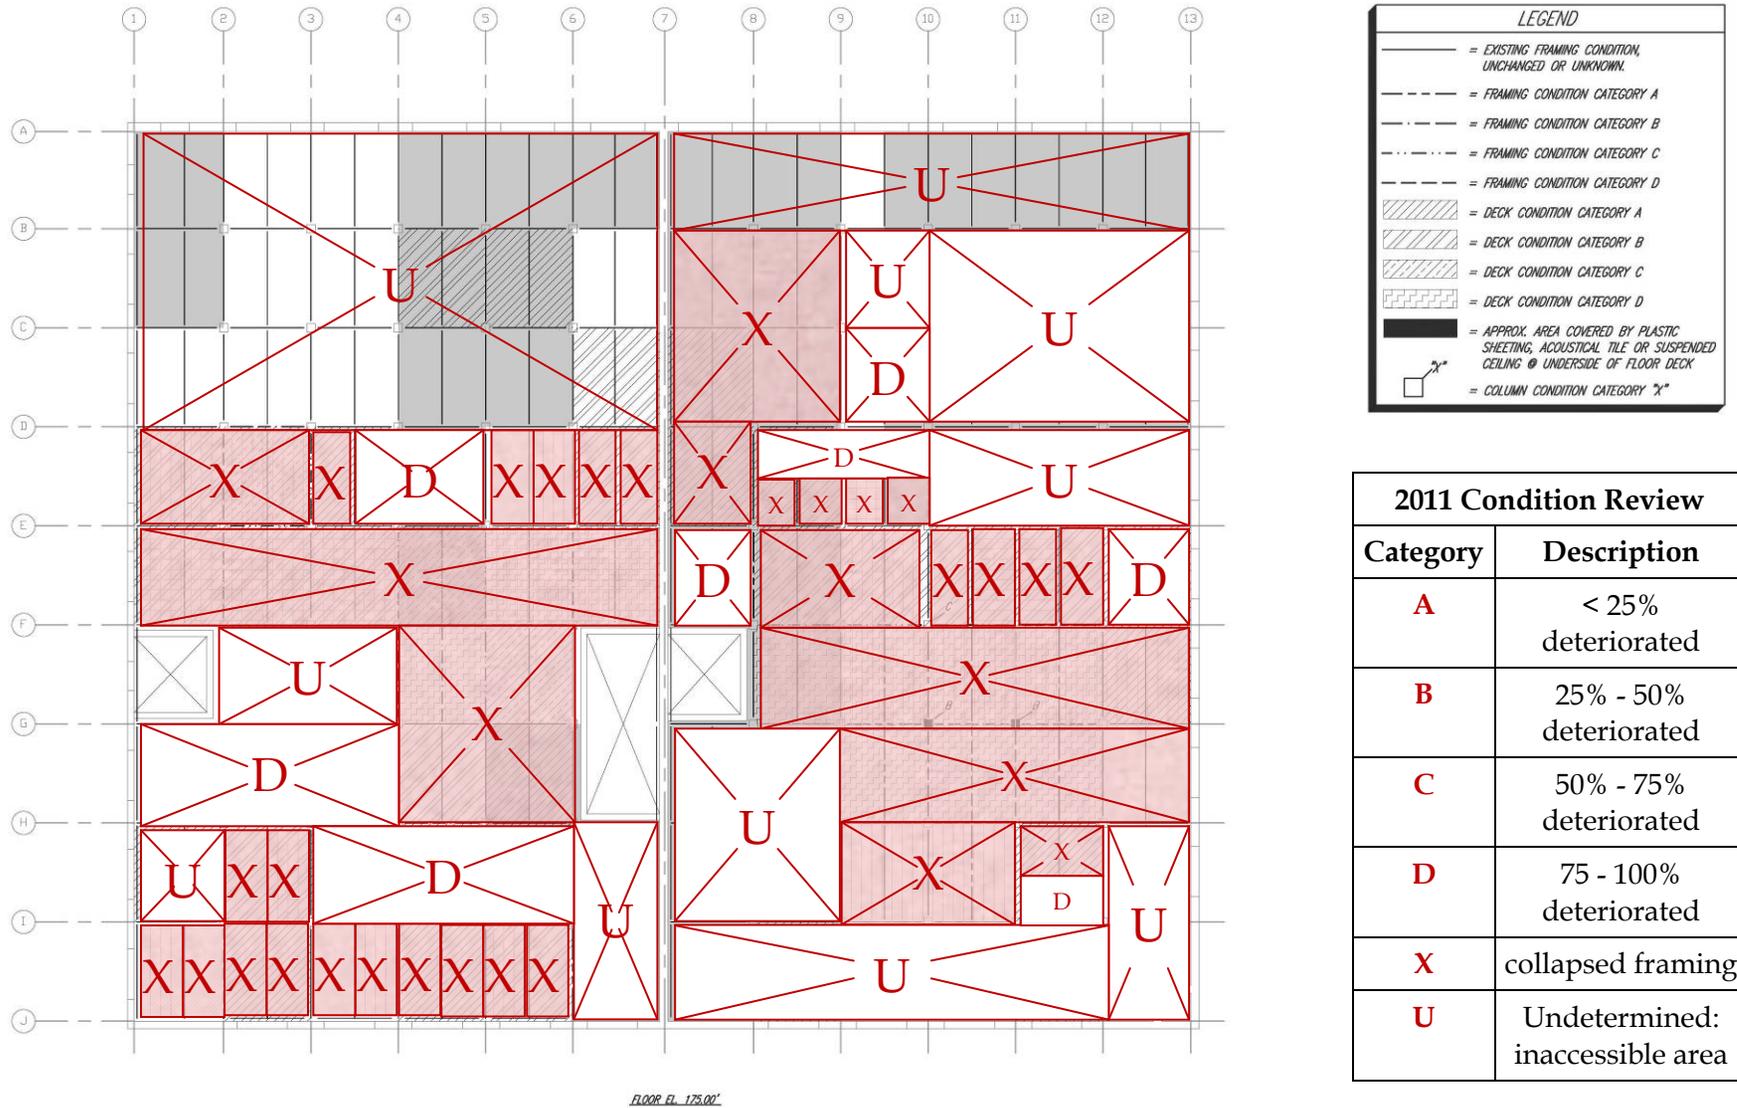
Figure A-8 - Seventh Floor Framing Plan - 2000 and 2011 (red)

2. Timber framing bays on the west side of the center wall, immediately adjacent to the stair shaft, have experienced significant areas of partial or total collapse from the roof level down into the basement. In addition, timber framing adjacent to the west wall at the Seventh Floor and Roof levels has partially collapsed. These areas are shown on the framing plans in Appendix A and in photos B-5 through B-7. An imminent collapse hazard is present due to the column supporting the Sixth Floor framing north of the stair shaft having slipped off the bearing plinth below, as shown near the right edge of Figure B-6.

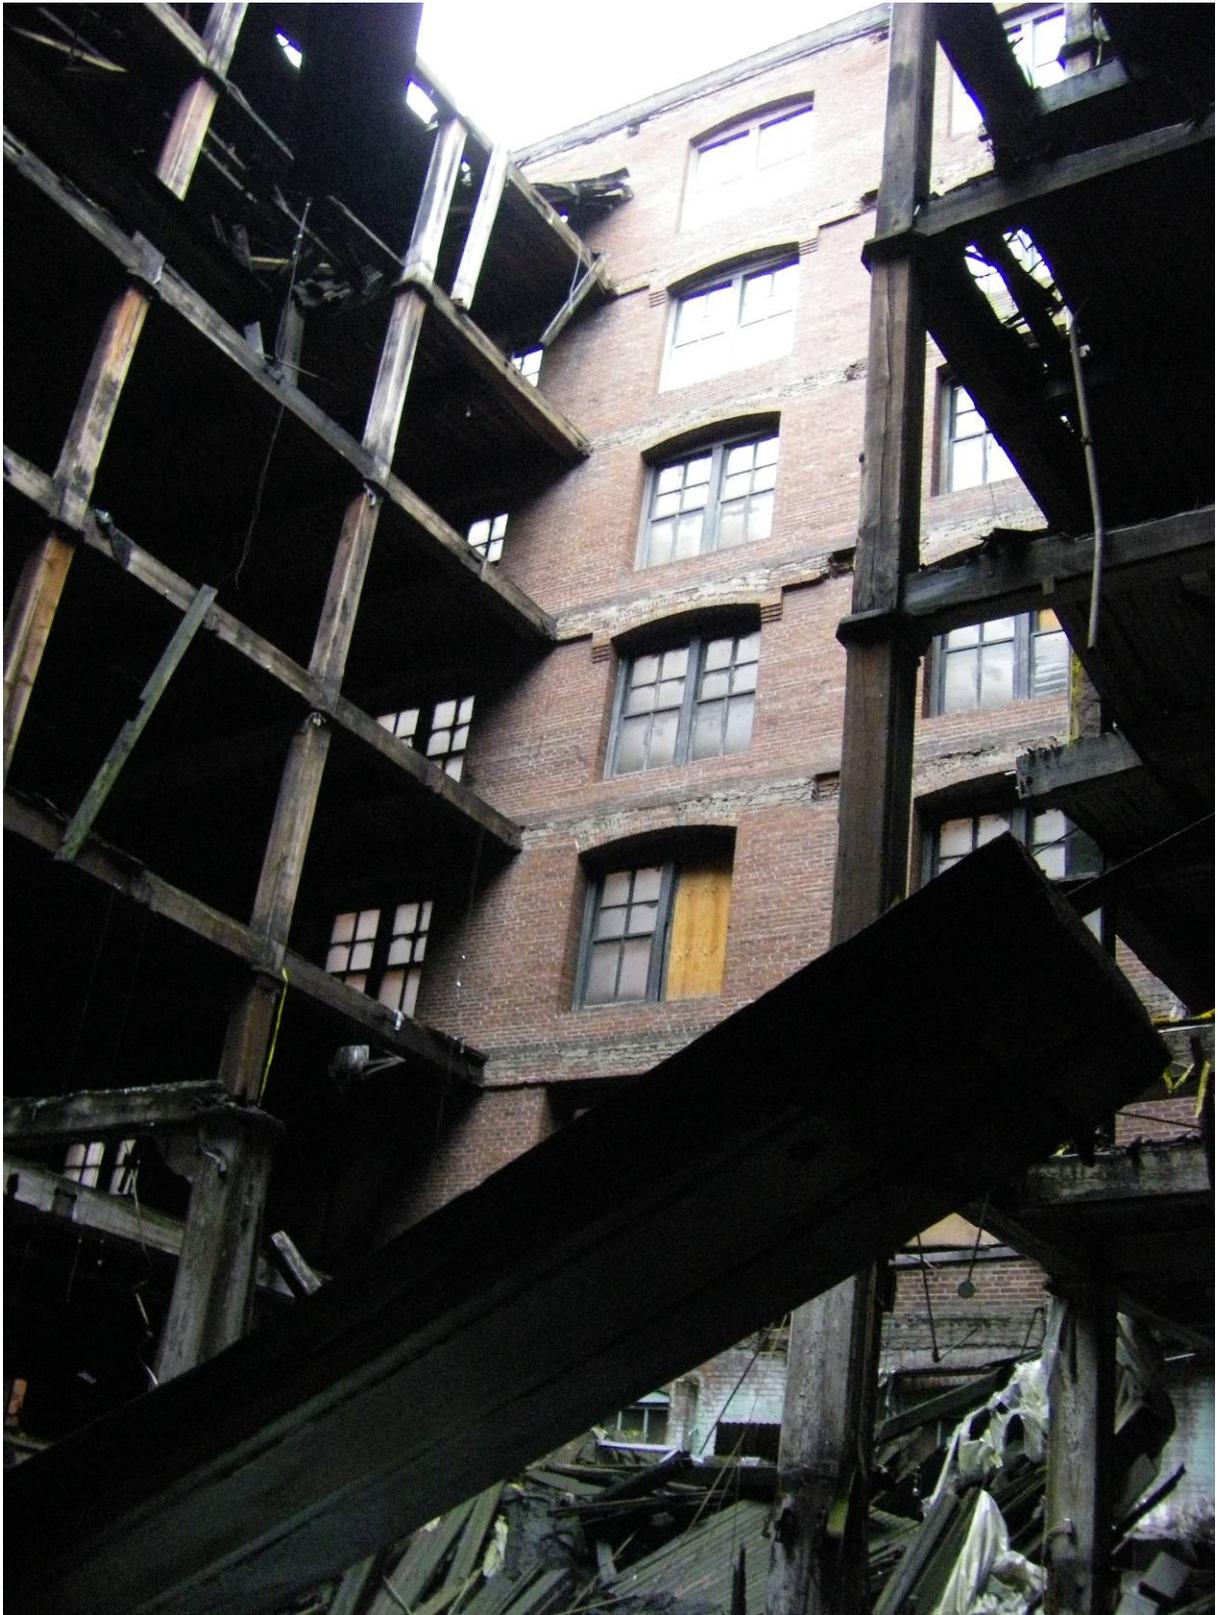
1. Timber framing bays on the east side of the center wall have experienced significant areas of partial or total collapse from the roof level down into the basement. These areas are shown on the framing plans in Appendix A and in photos B-1 through B-4.

5. Loss of lateral support for unreinforced masonry walls due to partial or complete timber framing collapses, as well as weakened conditions of remaining timber bays, has likely significantly affected the lateral stability of these walls. Unbraced walls, such as the east wall shown in Figure B-1, is currently very slender due to the loss of lateral support. Compounding this condition is the presence of a vertical crack through the masonry spandrels at this location, which has compromised the structural capacity of the brick arches over the window opening. A noticeable gap has opened up between the top of the Seventh Floor window frame and the brick arch above, possibly indicating vertical downward displacement of the brick spandrel below and a falling hazard posed by the window frame..

Figure B-1 : East Side Partial Collapse, Looking Northeast

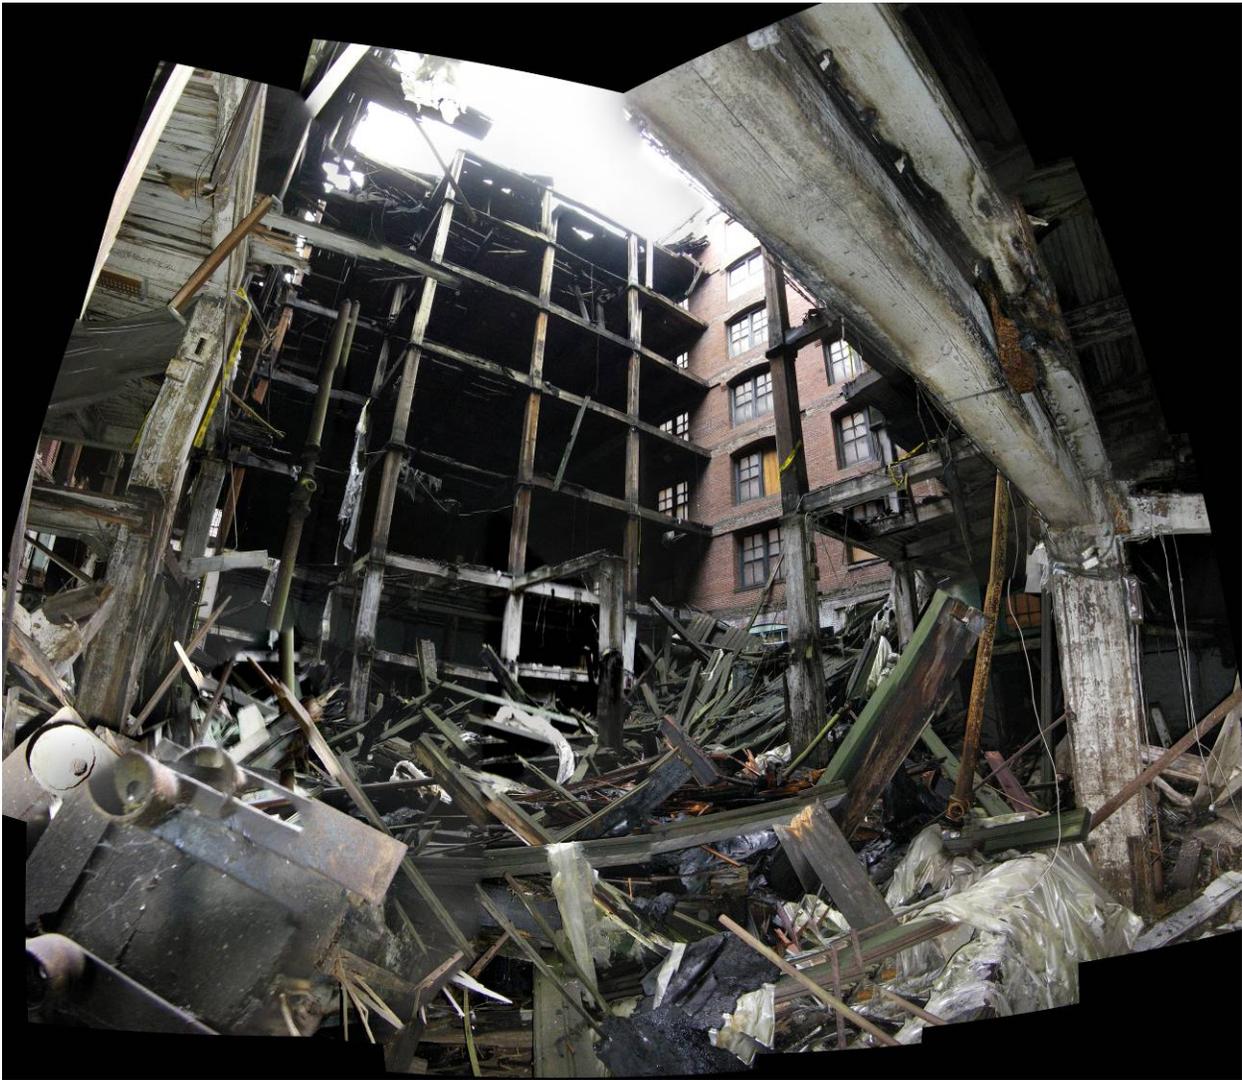
Figure B-2 : East Side Partial Collapse, Looking Northeast (composite image)

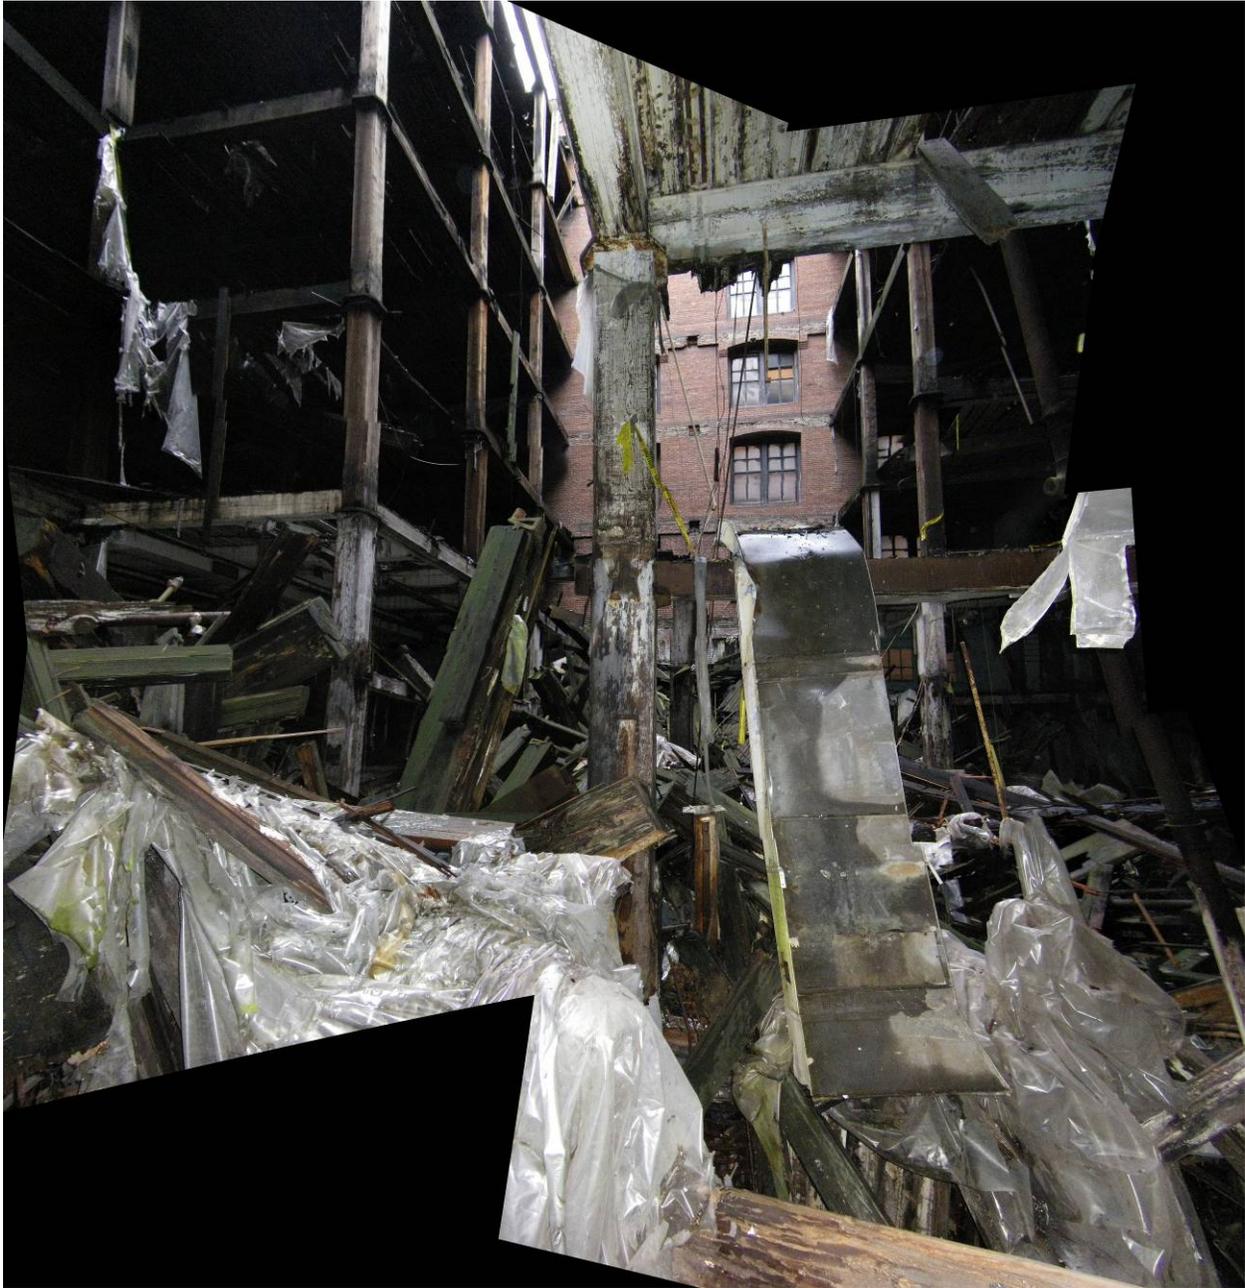
Figure B-3 : East Side Partial Collapse, Looking East (composite image)

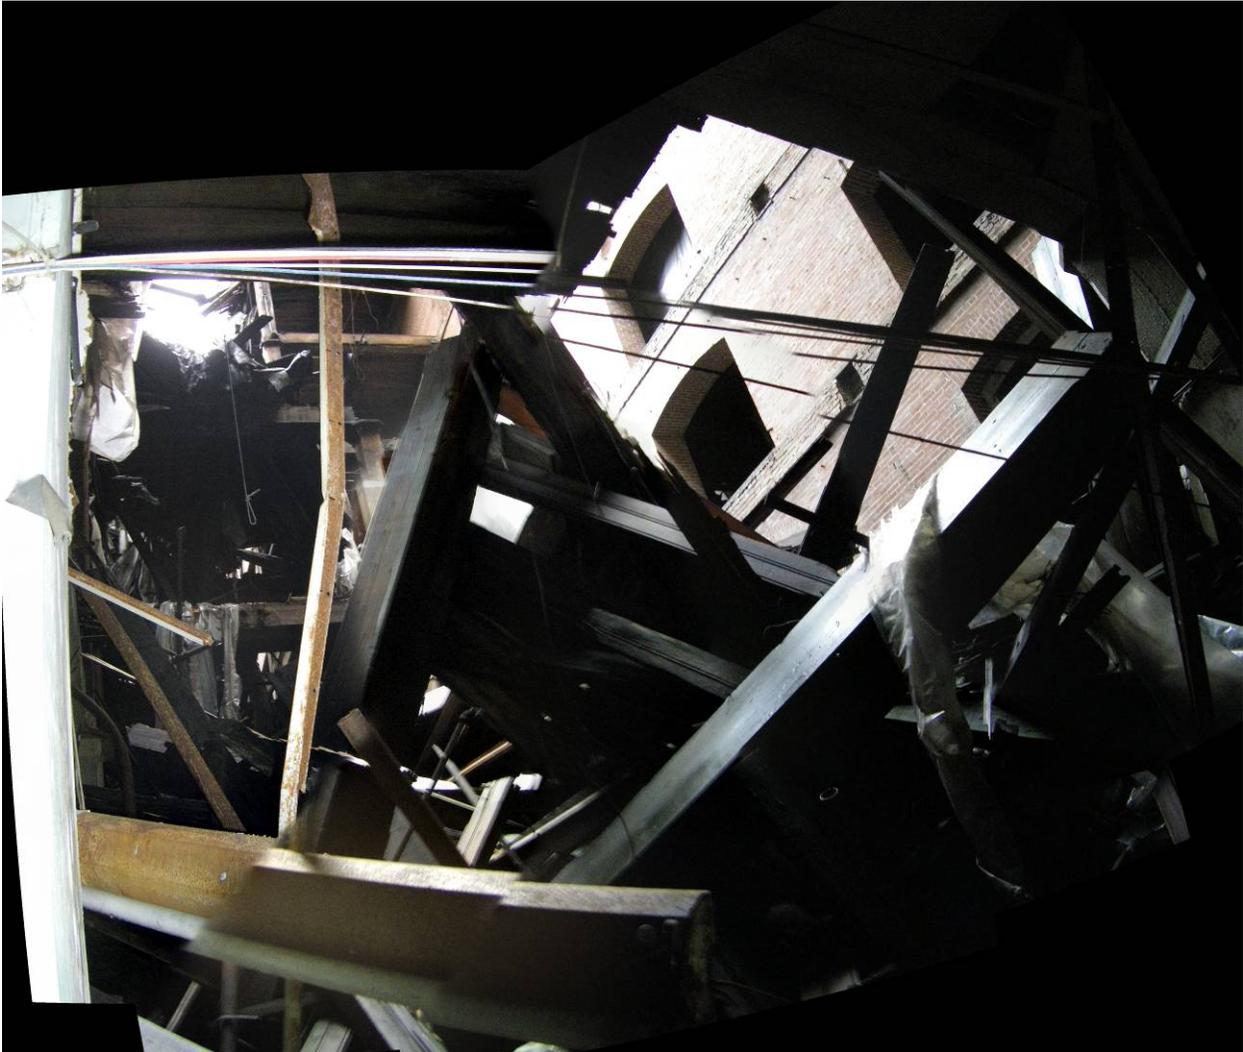
Figure B-4 : East Side Partial Collapse, Looking Southwest at Center Wall (composite image)

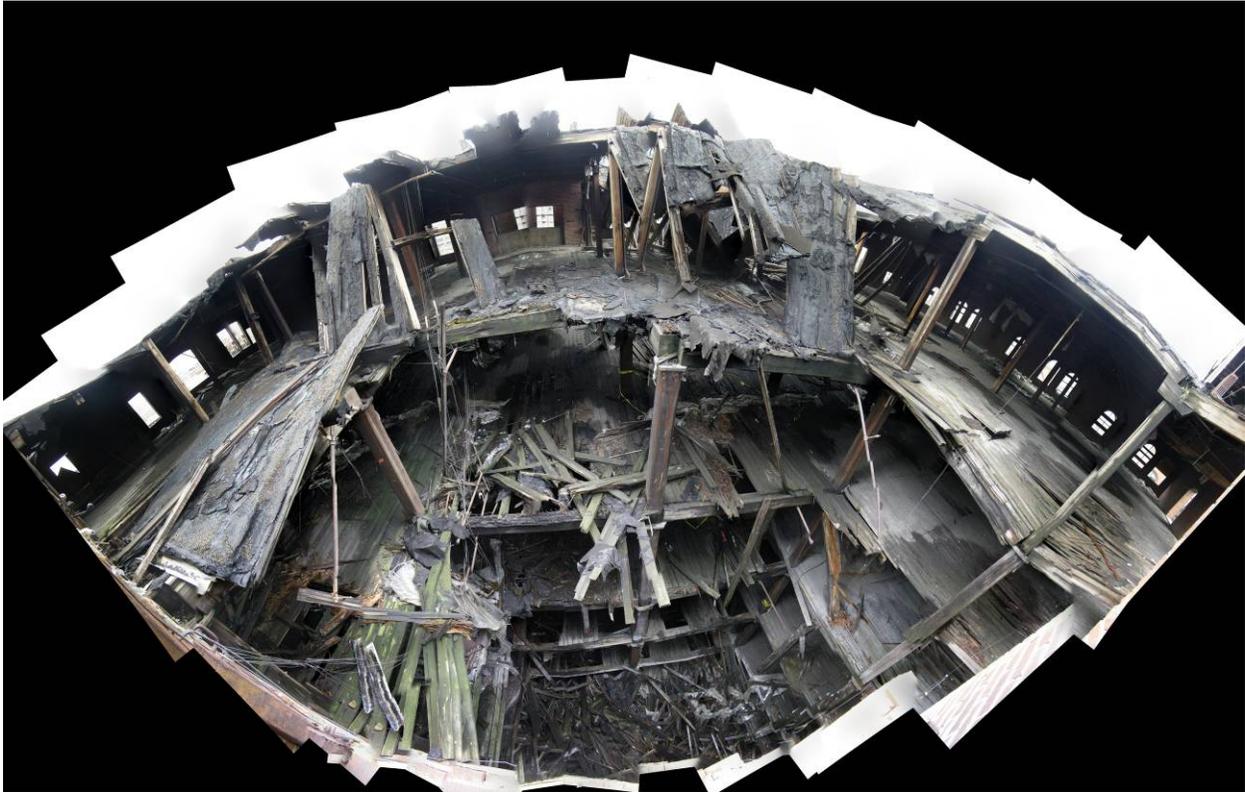
Figure B-5 : West Side Partial Collapse, Looking West from Seventh Floor Door in Stair Shaft  
(composite image)

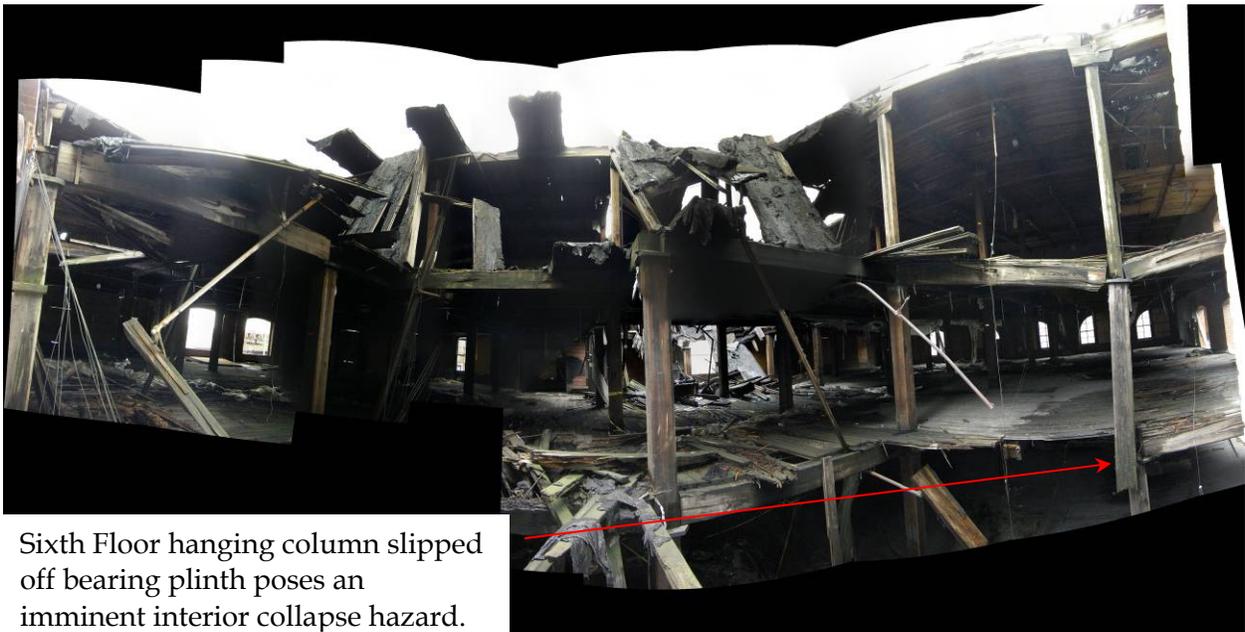
Sixth Floor hanging column slipped off bearing plinth poses an imminent interior collapse hazard.

Figure B-6 : West Side Partial Collapse, Looking West from Sixth Floor Door in Stair Shaft.  
(Note partial collapse in background along west wall; composite image)

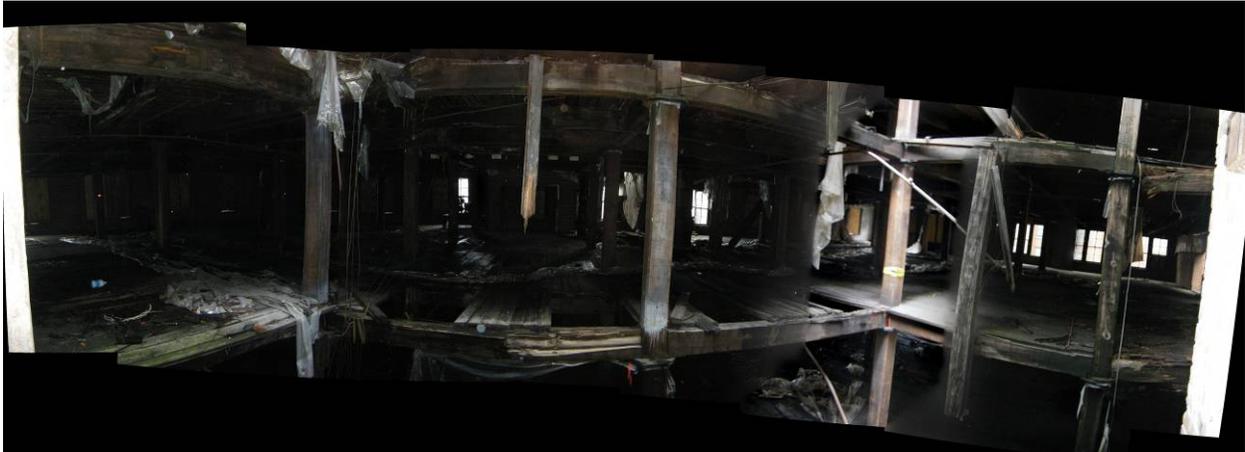
Figure B-7 : West Side Partial Collapse, Looking West from Fourth Floor Door in Stair Shaft (composite image)

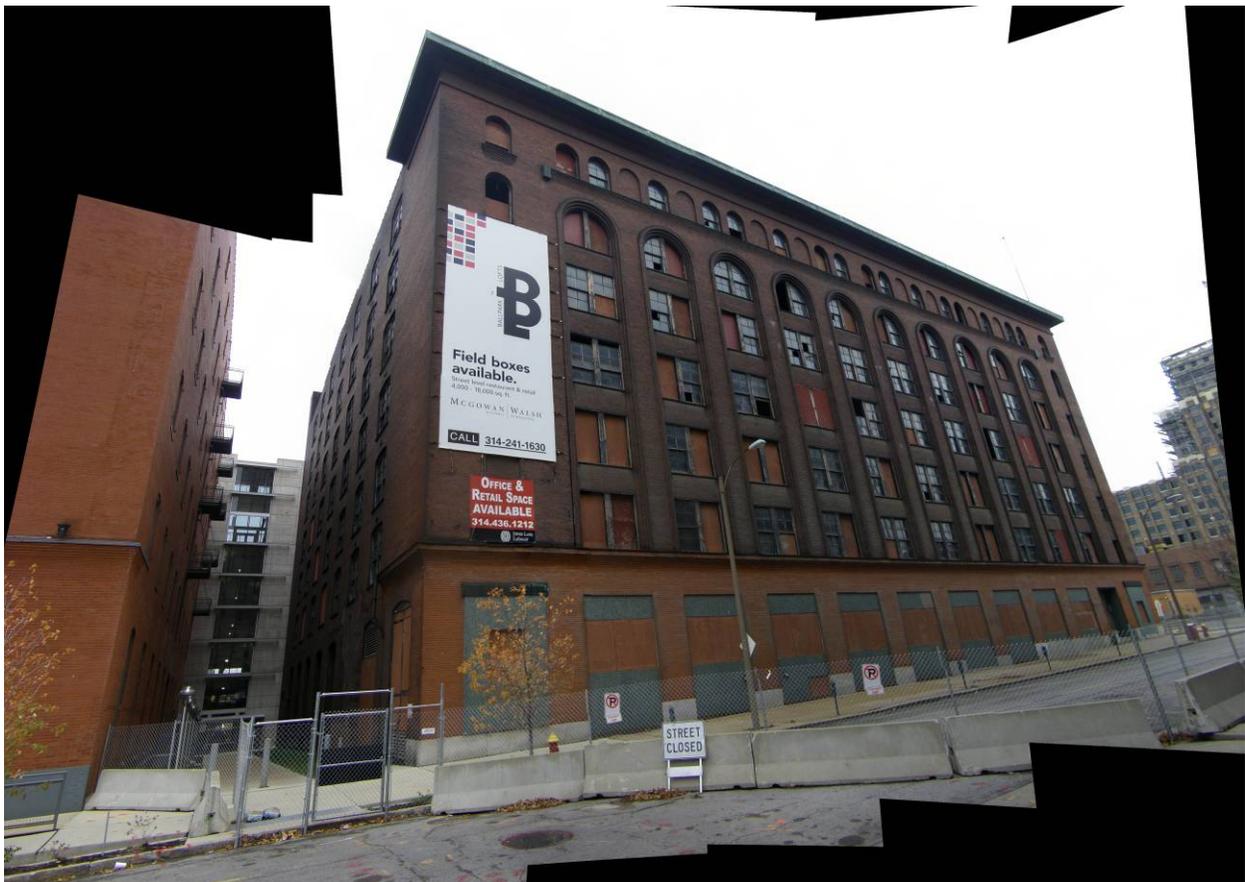
Figure B-8: East and North Facades, Looking Southwest (composite image)

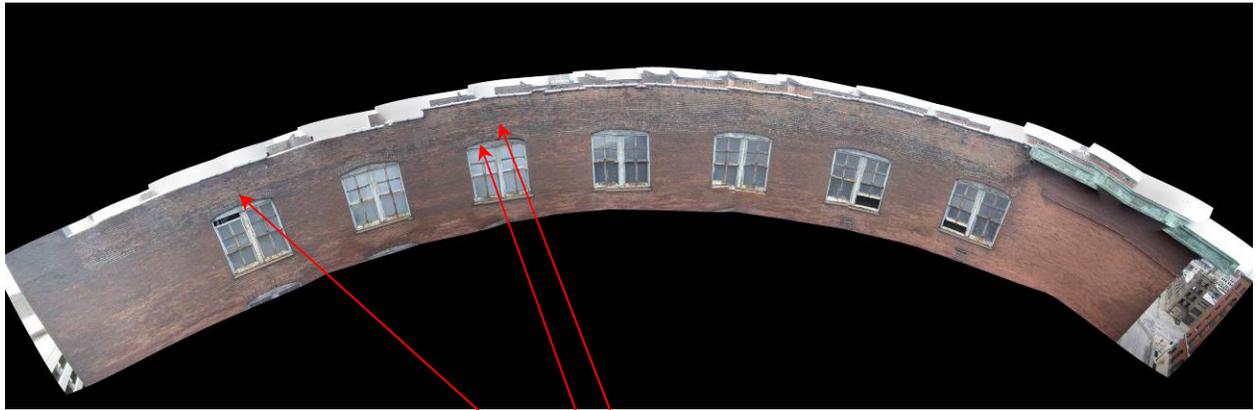
Vertical crack through window opening arch  
Dropped window frame  
Vertical crack through window opening arch

Figure B-9 : East Wall Parapet and Seventh Floor Windows, Looking West (composite photo)

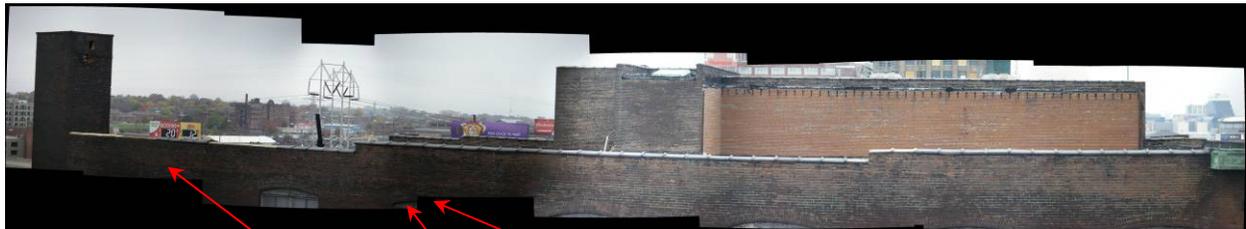
Vertical crack through window opening arch  
Dropped window frame  
Vertical crack through window opening arch and brick above

Figure B-10 : East Wall Parapet and East Wall of Penthouse, Looking West (composite photo)

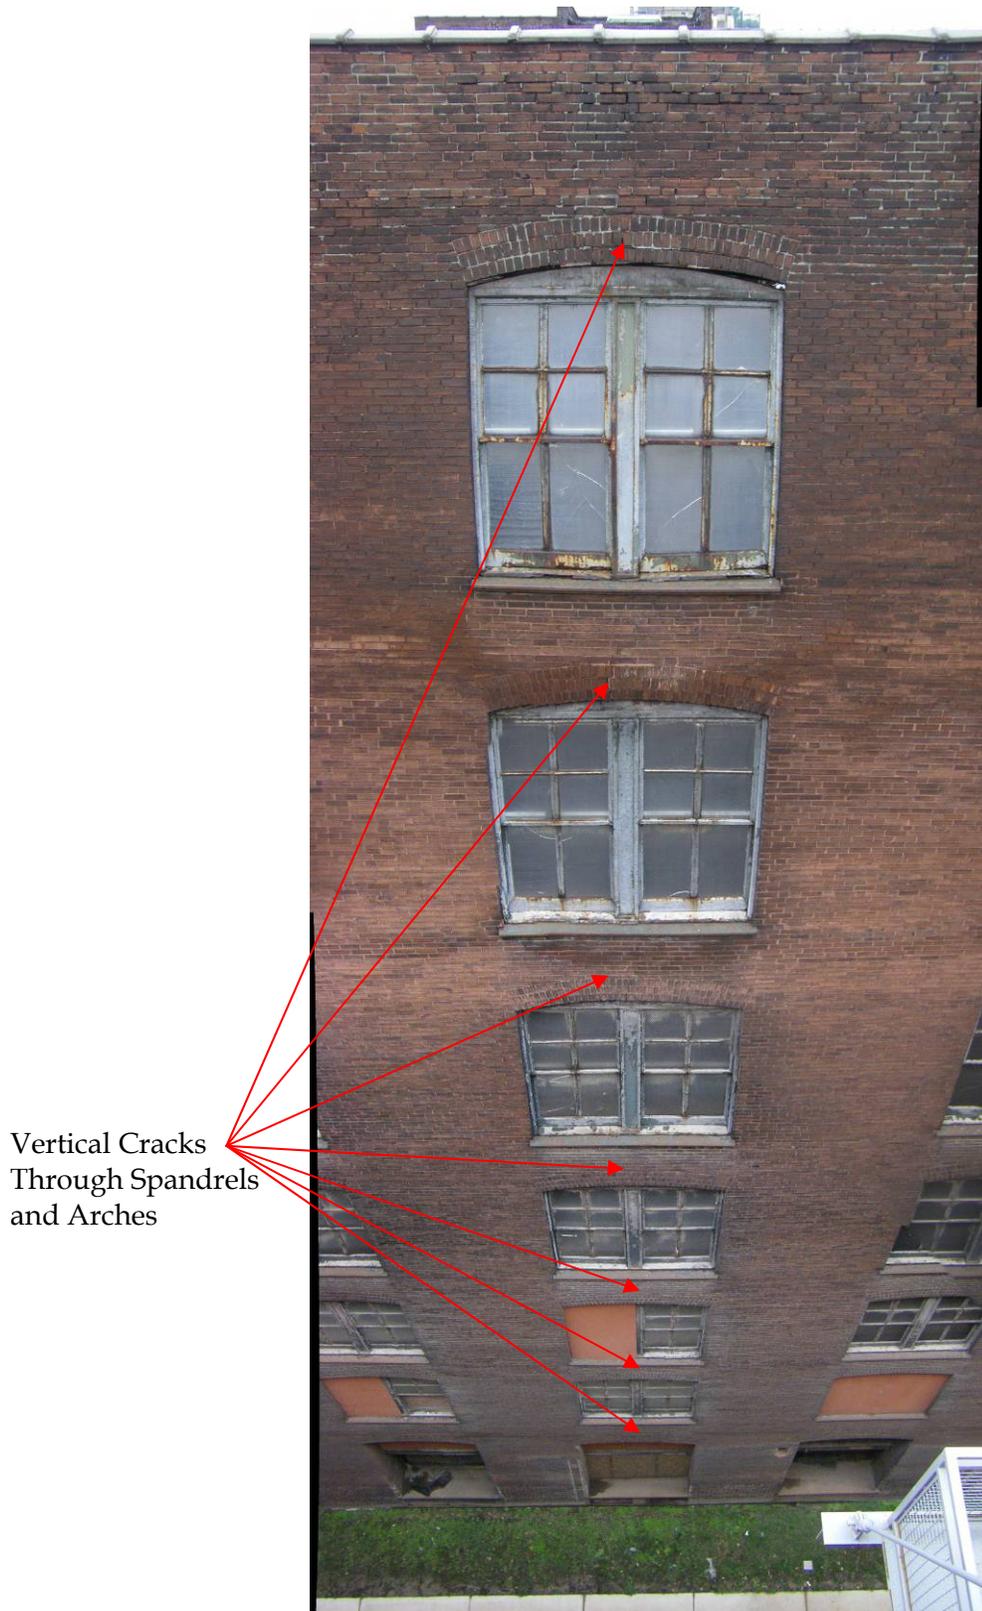
6. Cracking patterns noted during review of exterior walls indicate that lateral tension exists in the east, south and west walls. Cracks extend vertically through spandrels and arches, weakening both the in-plane and out-of-plane capacity of these wall to resist lateral loads. Crack patterns seem to indicate a general rotation of the south wall outward at the top, away from the structure. This condition is likely caused by leaking gutters and downspouts at the south wall, the low point of the sloped roof, which are possibly contributing to decay of wood piles supporting the south building wall. Vertical downward displacement of the south wall may also be occurring.

Figure B-11 : East Wall Vertical Crack Through Spandrels (composite imste)

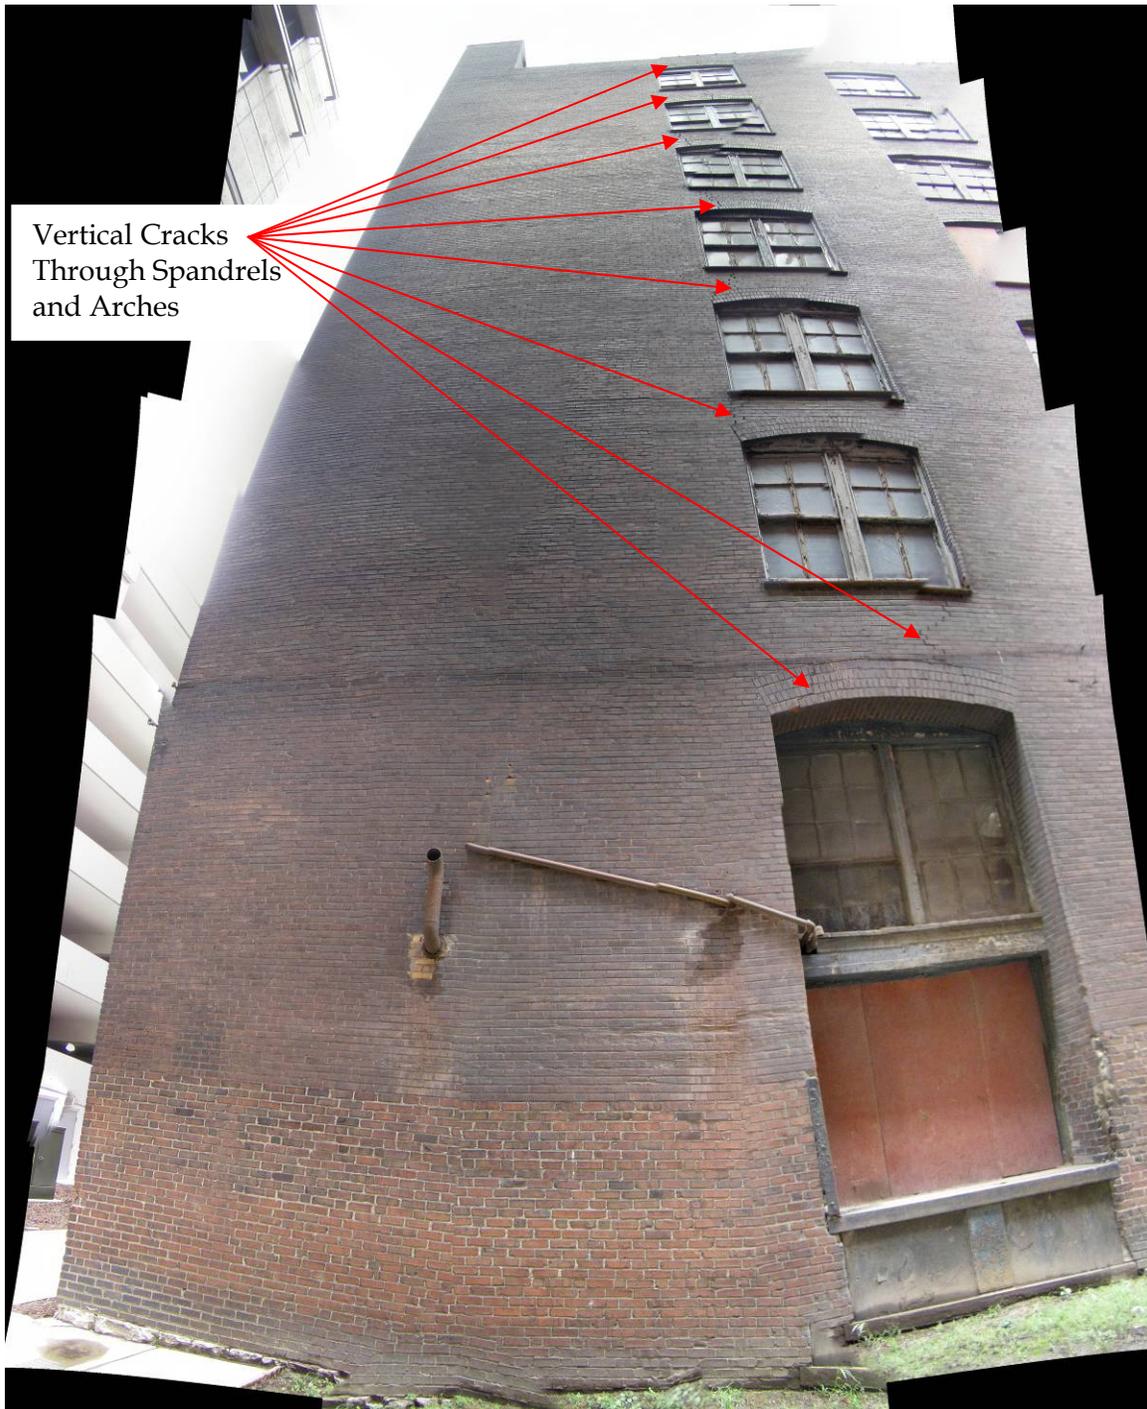
Figure B-12 : East Wall Crack Through Spandrels Near Southeast Corner (composite image)

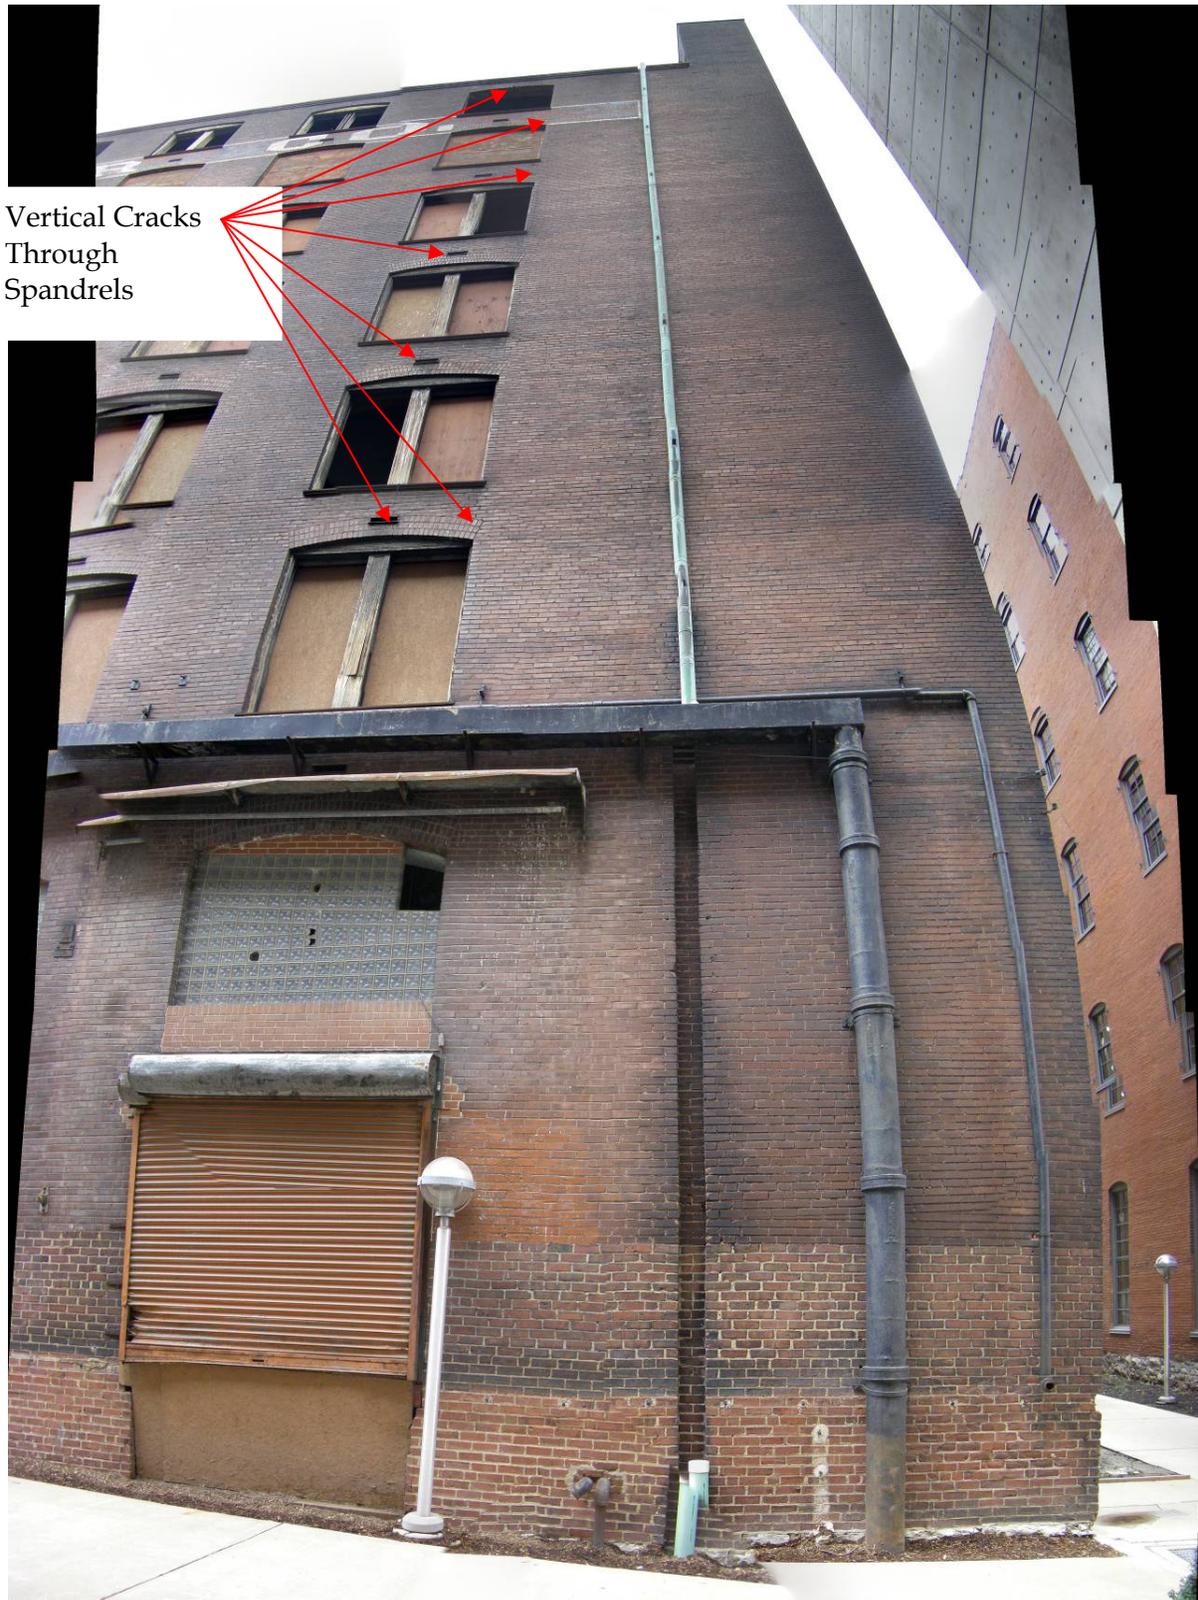
Vertical Cracks  
Through  
Spandrels

Figure B-13: South Wall Crack Through Spandrels Near Southeast Corner (composite image)

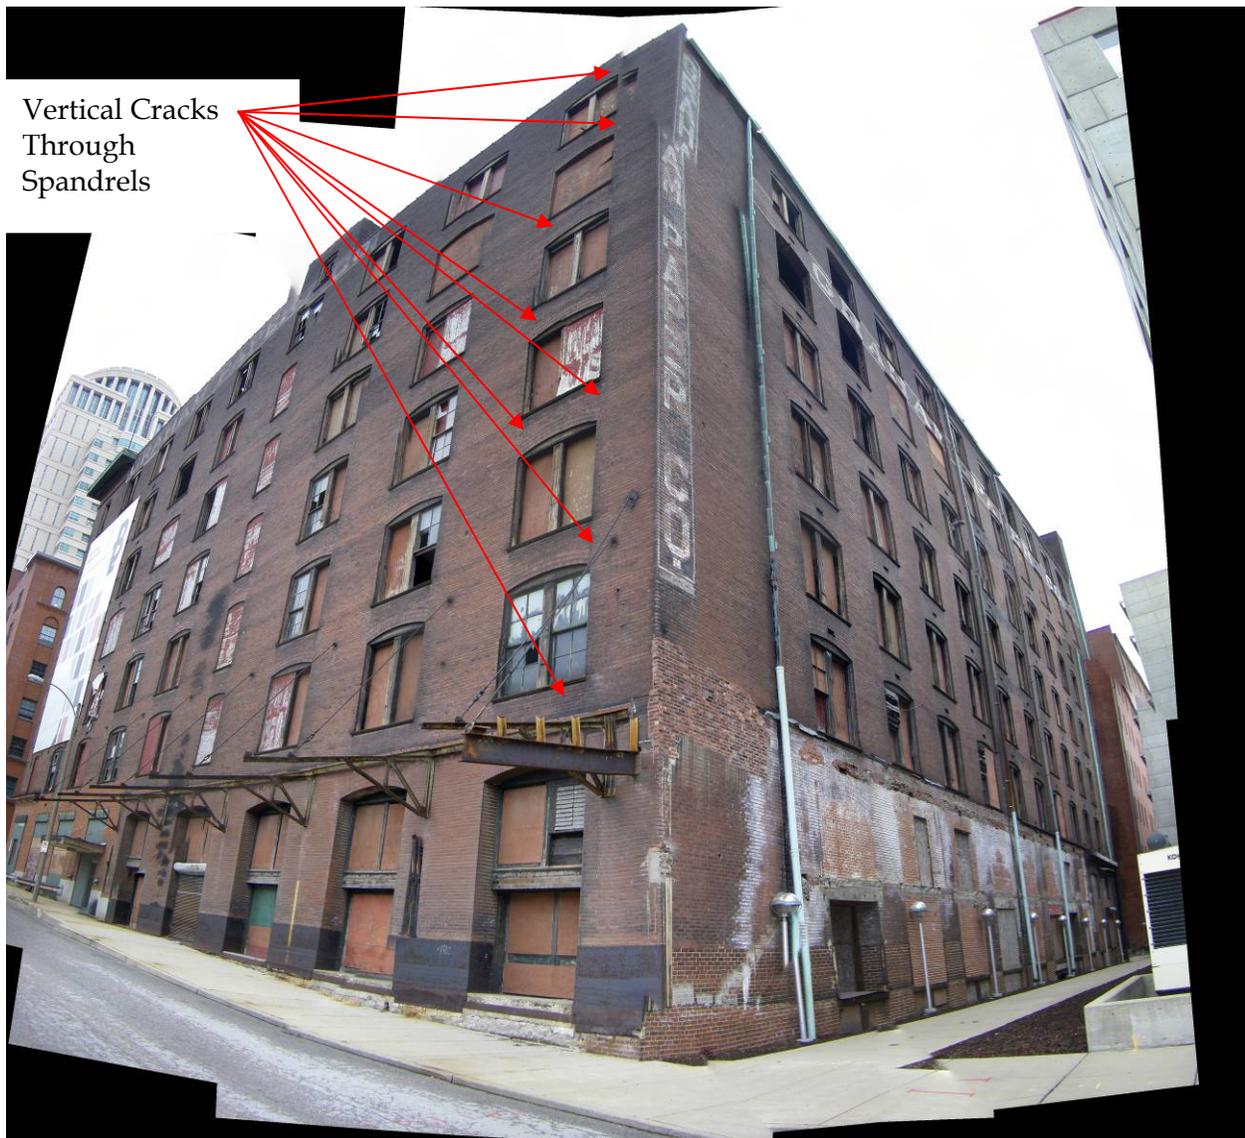
Figure B-14 : West Wall Cracks Near Southwest Corner (composite image)

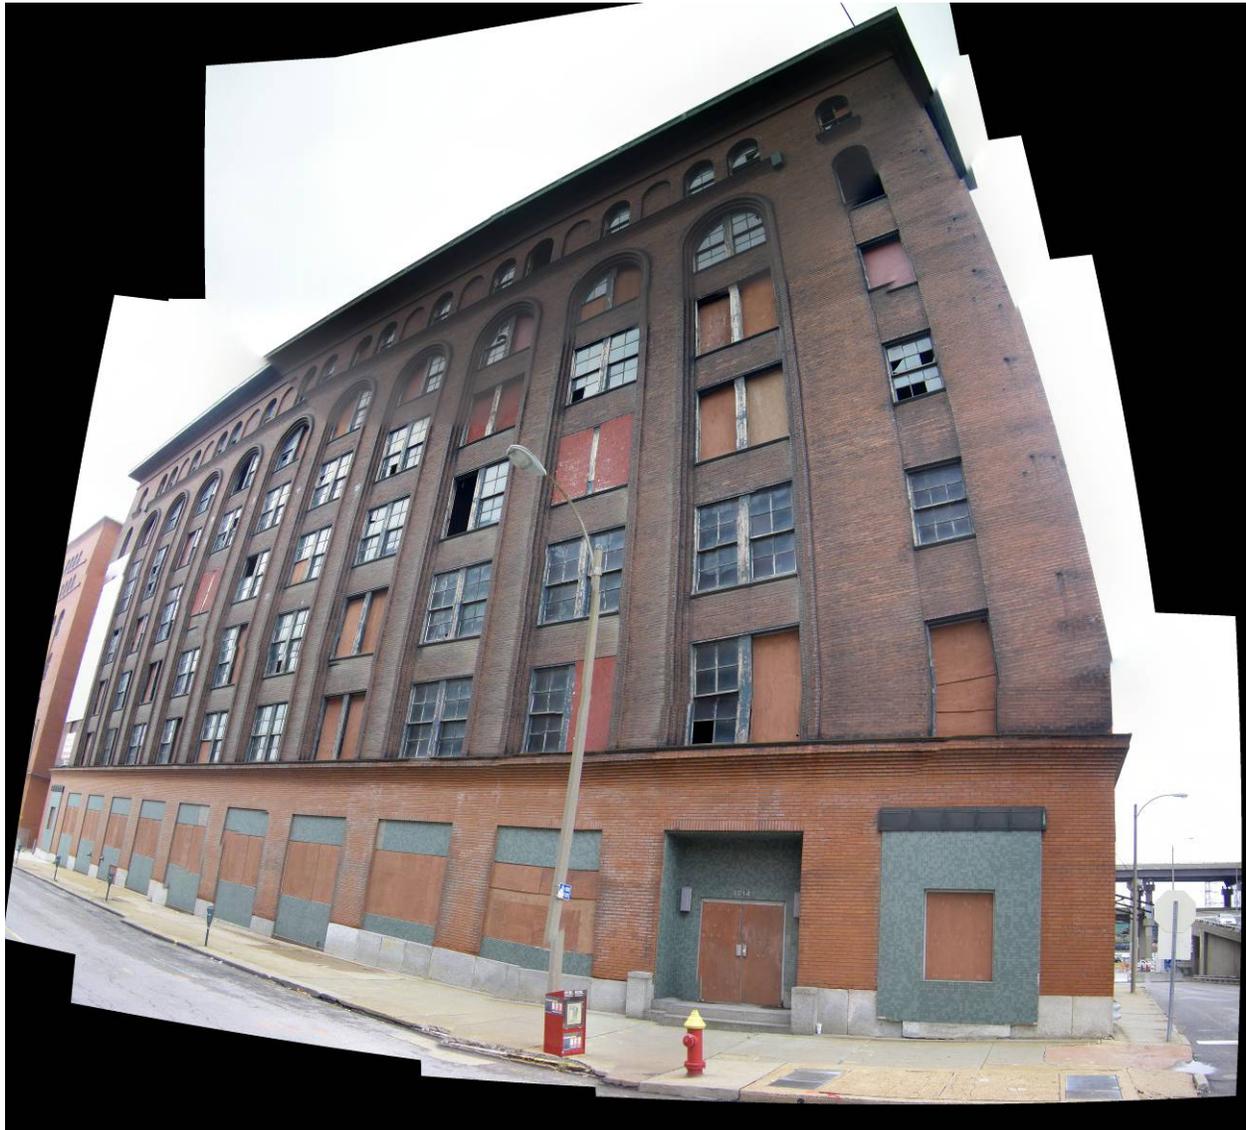
Figure B-15 : North Facade (composite image)
