City of St. Louis
Board of Public Service

**MUNICIPAL RIVER TERMINAL
SEWER CONDITION ASSESSMENT**

December 14, 2012

ST. LOUIS BRIDGE CONSTRUCTION COMPANY

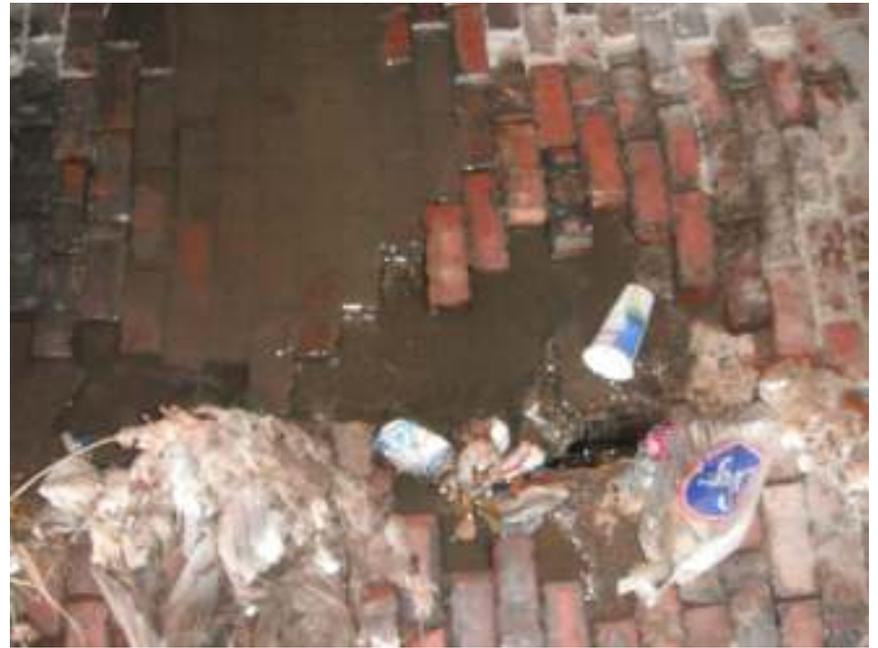
DSCF0106

The Branch sewer is a 14' wide by 11' high reinforced concrete horseshoe with brick lining at the invert. Overall, the sewer is in good condition, but minor concrete spalling, circumferential cracks, and mineral deposits were observed at various points throughout the reach. The most significant defects were observed at the downstream end of the pipe where flow was spilling into a void below a pipe separation at the invert and daylight was visible at the crown. This section of sewer is separated from the rest of the pipe with no proper jointing as observed during inspection. Exposed rebar was also noted near the end of the pipe.

Station	Defect	Description	Position	Photo
1+62		Minor circumferential crack, Leaking salt deposits		
1+77		Missing joint, Last section including invert separated from sewer, 5" wide separation		106, 107 , 108
		Flow slipping into separation @ invert, day light visible at crown		
	Measured at separation	18" thick invert with 4" brick overlay, 2ft thick vertical walls with 18"thick arch		
1+87		Minor circumferential crack	2:00 - 5:00	
2+00		General condition looking upstream		109
2+05		Hole with exposed rebar	12:00	110
2+08 to Outfall		Concrete spall with rebar exposure	3:00 - 5:00	111
2+15.5		Outfall , General photo		112

The plan view of the entire MRT property with location of all the sewers within the property boundary is included in Appendix C . Based on the field inspections it was observed that the sewers were in general good condition without any major defects of immediate concern. However, the separation of the last section of Branch sewer should be further evaluated for structural integrity of the sewer. Significant silt and debris were noticed in Benton and North Market sewers obstructing flow.

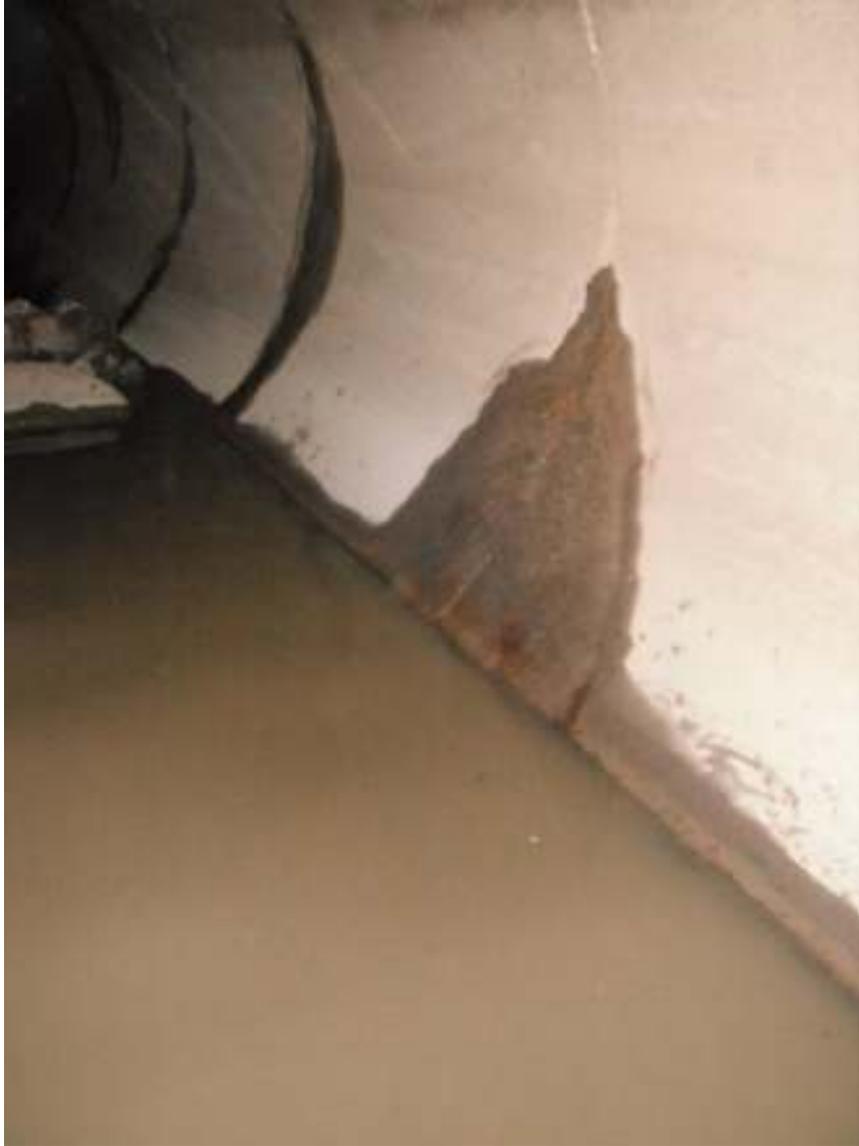
DSCF0118

0+71		Minor offset joints, Water leak and deposits through joints.		118 , 119
1+00		General condition of pipe looking downstream		120
1+50		General condition of pipe looking downstream		121
1+80		Manhole	12:00	122
2+00		General condition of pipe looking downstream, Pipe bends to left		123
2+25		Pipe bend		
2+50		General condition of pipe looking downstream		124
3+00		General condition of pipe looking downstream		125
3+50		General condition of pipe looking downstream		126
4+00		General condition of pipe looking downstream		127
4+35		End of 60in pipe looking upstream		128
		Looking downstream at outfall from access structure		129

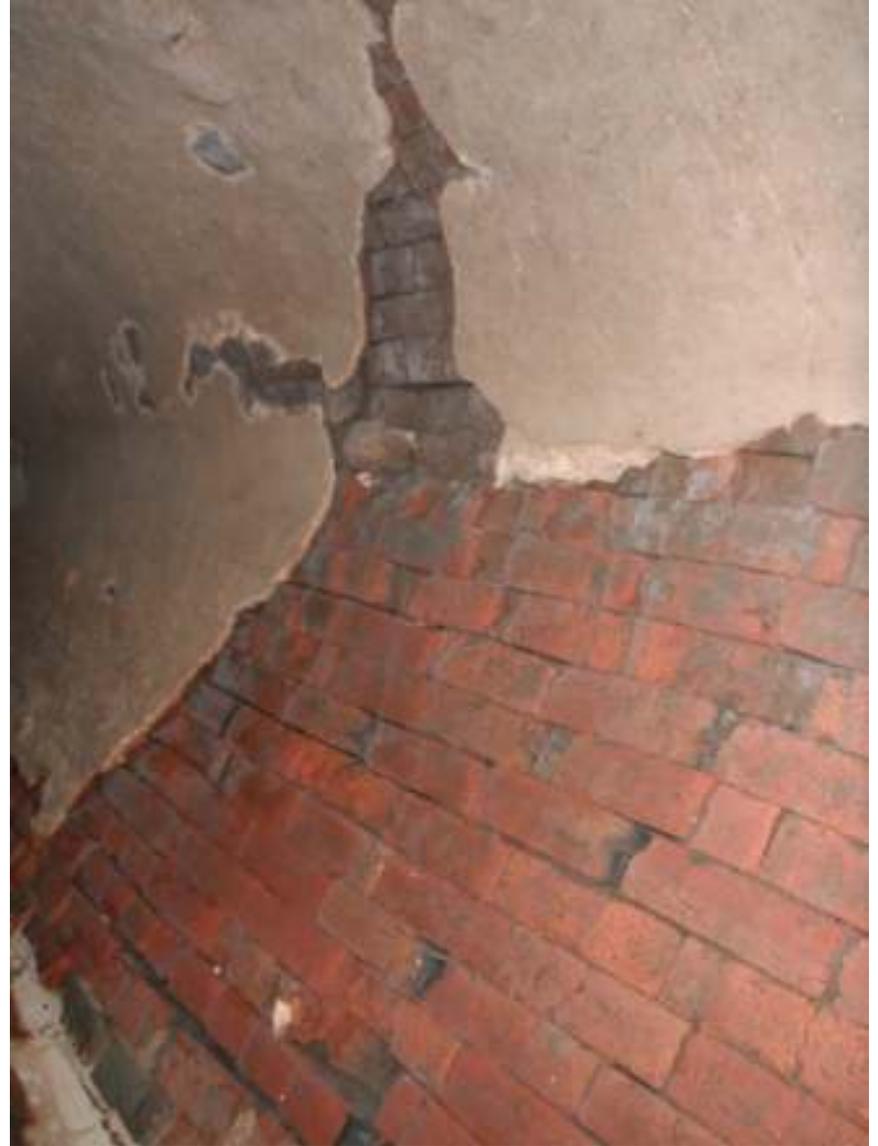
DSCF0220

The Chambers sewer consists of a 54" reinforced concrete pipe in good condition at the upstream end, transitioning to a 48" wide by 60" high brick egg shaped sewer with gunite lining, and then to a 48" wide by 60" high reinforced concrete box at the outfall. Missing bricks and spalled gunite lining were observed in several places throughout the brick egg shaped sewer. A significant dip with standing water was also observed in the reinforced concrete box upstream of the outfall.

1+00 - 1+15		Missing gunite lining		
1+15		Missing bricks	9:00, 3:00	220 , 221
1+35		Pipe turns right		222
1+50		General condition of pipe looking downstream		223
1+68		6in Drop in pipe invert		
1+75		General condition of pipe looking downstream		224
2+06		Pipe transition to RCP box 48" W x 60" H ,		
2+18		4" deep hole in concrete wall	3:00	227
2+27		Minor crack in vertical walls		229 , 230
