**CULTURAL RESOURCES OFFICE  
PRESERVATION BOARD  
REGULAR MEETING  
MONDAY JUNE 24, 2013 — 4:00 P.M.  
1520 MARKET ST. #2000  
[www.stlouis-mo.gov/cultural-resources](http://www.stlouis-mo.gov/cultural-resources)**

DATE: June 24, 2013  
ADDRESS: 2856 Salena Street  
ITEM: Preliminary Review to install new front door and entryway.  
JURISDICTION: Benton Park Certified Local Historic District — Ward 9  
STAFF: Bob Bettis, Cultural Resources Office

DATE: June 24, 2013  
ADDRESS: 2720-22 South Jefferson Avenue  
ITEM: Preliminary Review to install 10 windows on the front façade in response to the denial of recent application to retain non-compliant windows.  
JURISDICTION: Benton Park Certified Local Historic District — Ward 9  
STAFF: Bob Bettis, Cultural Resources Office

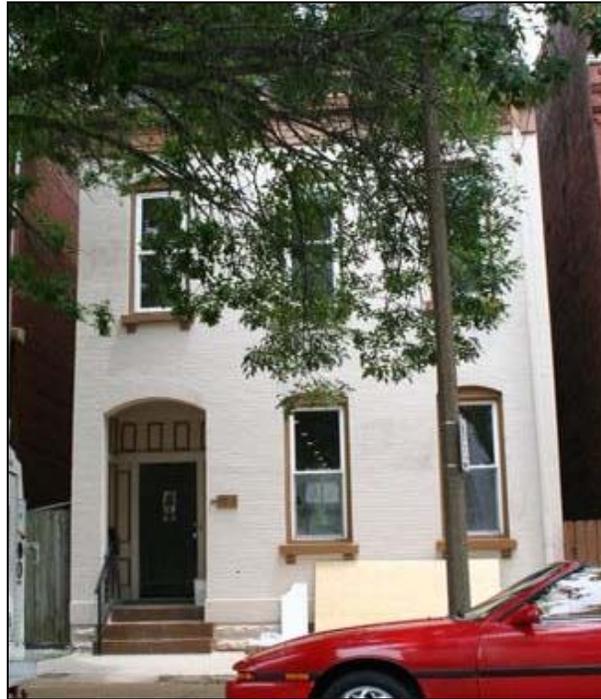
2856 SALENA ST.

**RECOMMENDATION:**  
That the Preservation Board deny the Preliminary application as the proposed entryway does not meet the Benton Park Historic District standards.

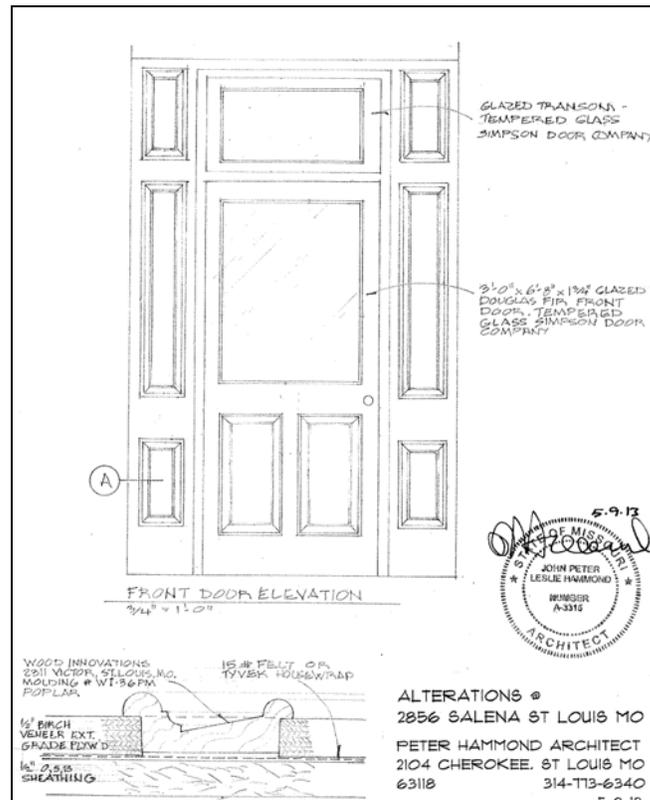
**PROPOSED ENTRY**

Does not comply as the proposed entry does not replicate the original condition or a Model Example. The original entry consisted of two angled doors as shown by evidence on the interior and given the width of the exterior opening. At some point the entry was modified to incorporate a single centered door that does not meet the current district standards. The proposed alteration is for a single door with flanking side panels. The proposed door, which has already been purchased, does not match the original panel configurations which are still extant on the reveals of the recessed entry.

- 2856 Salena is located in the Benton Park Local Historic District.
- The entry’s original configuration had two angled doors.
- The entry of the building was reconfigured from paired doors to a single door yet some of the original design remains on the sides of the entrance.
- The proposed entryway is not based on an acceptable Model Example. The applicant has submitted examples of paired entries that are wider and have doors that are parallel to the façade as opposed to being placed in an angled position.
- The purchased door does not match the configuration of the existing historic paneling, as was the historic condition.

Based on the preliminary findings, the Cultural Resources Office recommends that the Preservation Board deny the Preliminary Application to replace the entry as it does not comply with the Benton Park Historic District Standards. The Office recommends that the applicant use a Model Example with two angled doors to recreate the historic condition or install a new door and surround that replicates the paneling and proportions of the existing historic material in the entrance.

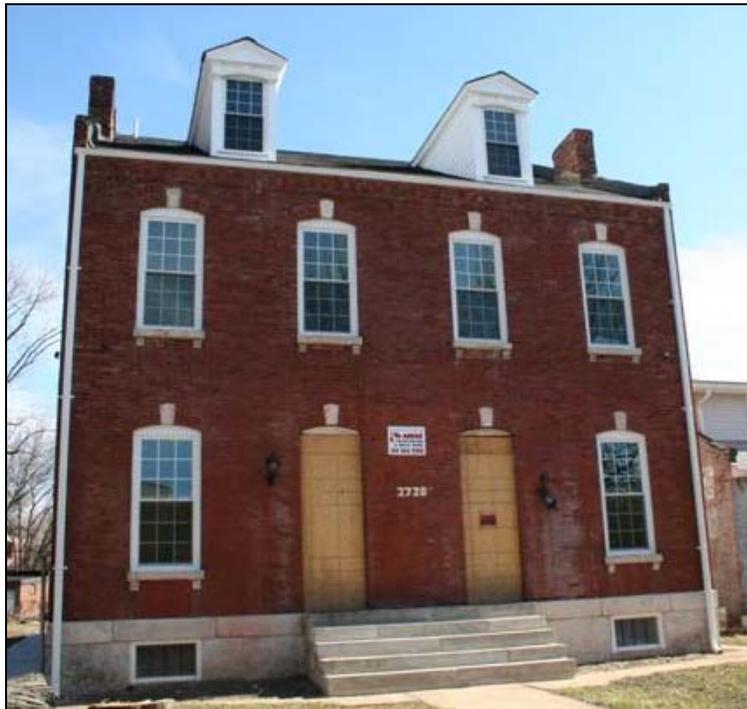
2720-22 SOUTH JEFFERSON AVE.

**RECOMMENDATION:**  
That the Preservation Board deny the Preliminary Application as the proposed windows do not comply with the Benton Park Local Historic District standards.

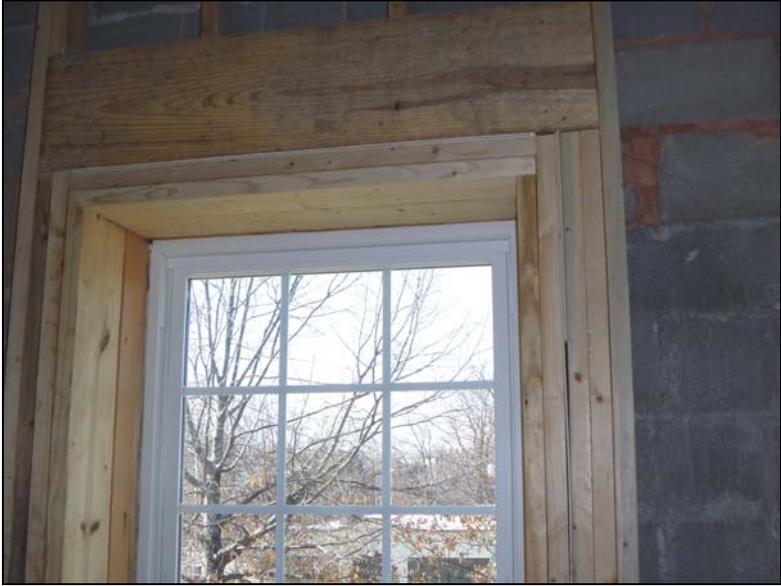
The proposed windows on the public façade do not comply with the Benton Park standards. The original windows, removed and replaced without a permit, had segmental arches. The owners propose to replace them with flat-headed windows, although the proposal would utilize windows from our approved list of replacement windows. The remaining three facades would retain their non-compliant windows.

**DETAIL OF INSTALLED WINDOWS WITH INCORRECT FRAMING**

The goal for this property now is to minimize the reduction of the historic appearance of the building caused by the existing windows. Two ways to move forward merit consideration: Replace the front façade sash with arched units so that the façade is compliant. Or, replace the non-compliant sash on all three visible sides of the building as an alternative to reframing the arched openings of the front windows. The Cultural Resources Office recommends consideration of these two alternatives rather than the owners' proposal as the appropriate means to mitigate the violation.

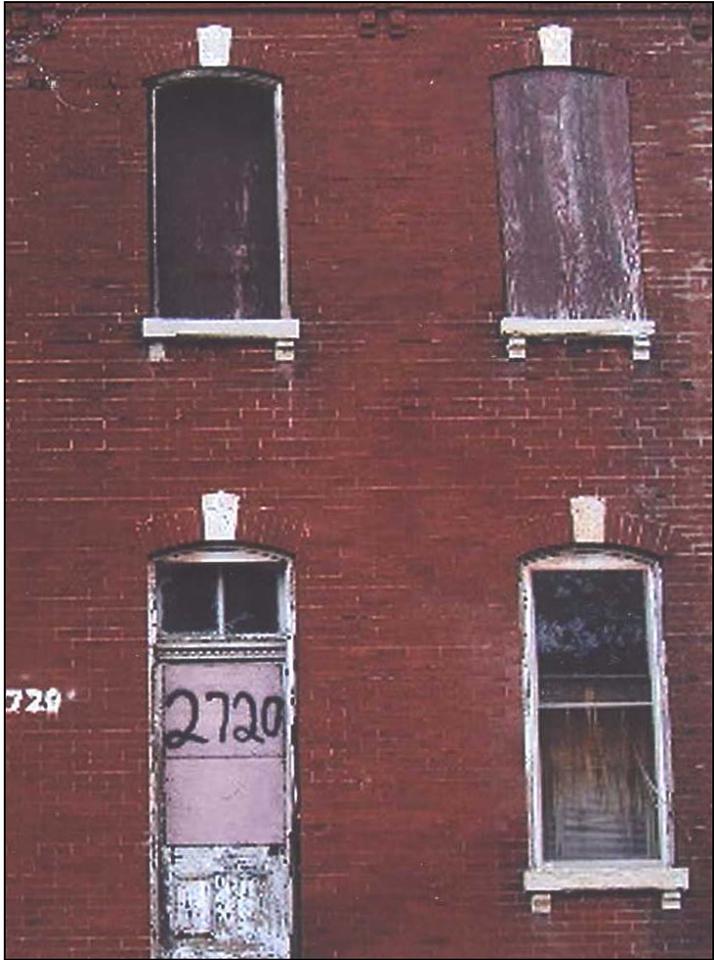
**PHOTO SHOWING ORIGINAL SEGMENTAL ARCHED BRICKMOLD EYEBROWS ADDED LATER TO INCORPORATE STORMS**
