LANDMARK DESIGNATION PETITION

1. Present Name of Site **Compton Hill Missionary Baptist Church**
2. Other Name(s)

1. Street Name and Number **3141 LaSalle Street**
2. City Block Number **1272**
3. Ward **6**
4. Structure is on original site: YES NO

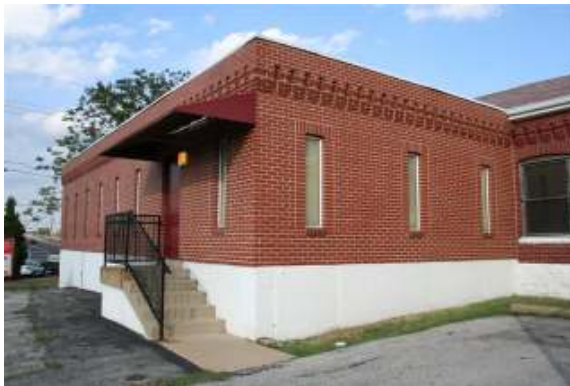
West Addition

The addition to the west side of the church is a flat-roofed brick building on a raised painted concrete foundation. The corbelling of the brick walls of the church is replicated on this addition. Concrete steps rise to an exterior door in the west wall. The narrow rectangular window openings have flat soldier arches, rowlock sills and are enframed by stacked brick, are outlined with the same color of brick as the walls. This is the administration area of the church and the Pastor's office.

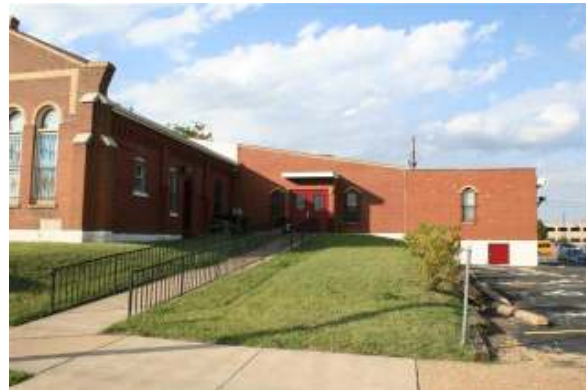
Memorial Hall Addition

Additions extend from the north end wall of the church, as well as from the north halves of the east and west walls, both considerably recessed from the church's primary facade. The one-story brick addition on the east side of the church comprises the Memorial Hall. A two-part construction program is evident. In the portion of the Hall closest to the church, a single-slope roof of low pitch slopes to the east. A ramp leads to a set of double doors at grade, sheltered by a canopy;; the entrance is flanked by windows with single rowlock arches of contrasting brick, mirroring similar details on the church. In the eastern section of the Hall addition, which has a flat roof, a similar window is centered in the south façade. The addition's poured concrete foundation is exposed on this section.
