Subject: Phase II Targeted Brownfields Assessment
Former Spotless Car Wash, St. Louis, Missouri
U.S. EPA Region 7, START 4, Contract No. EP-S7-13-06, Task Order No. 0002.017
Task Monitor: Todd Davis, EPA Site Assessment Manager

PHASE II TARGETED BROWNFIELDS ASSESSMENT REPORT

FORMER SPOTLESS CAR WASH, ST. LOUIS, MISSOURI

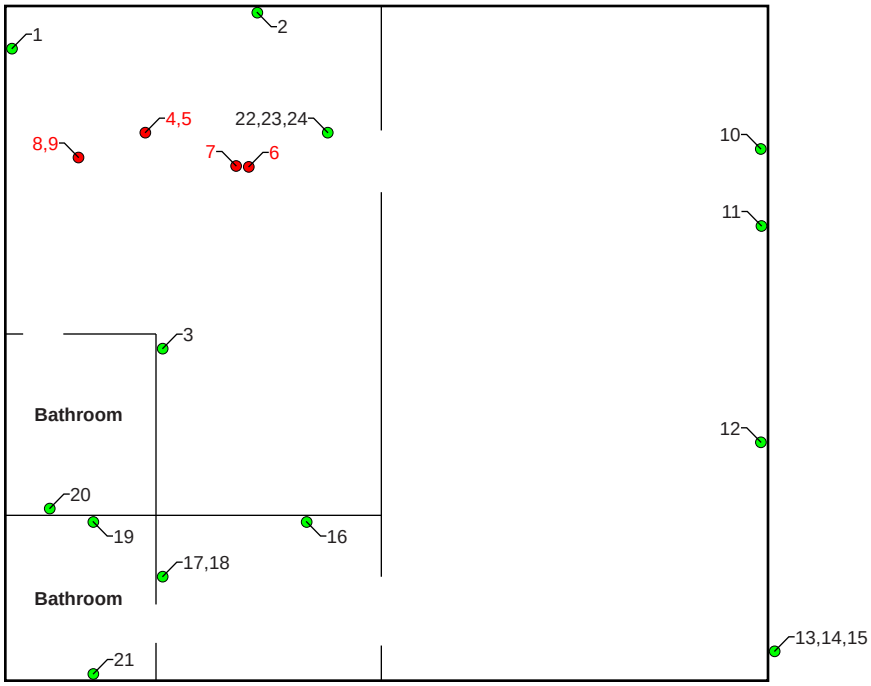
- As listed in Table 6, ACM sampling confirmed that approximately 300 square feet of floor tile from the subject property building contained 2-3% chrysotile asbestos.

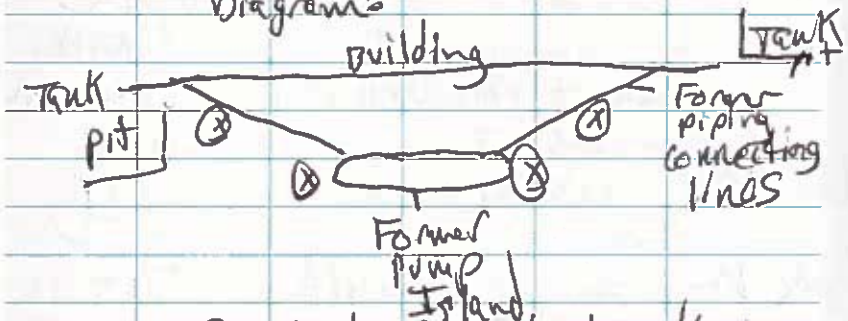
3-20-14 Former Spotless Carwash TBA
Deviations to the QAPP Continued
② Need 4 Geoprobe Samples around pump Island - two from each end of the island and two under attached piping line areas that run SW and SE of the island

⊗ = Geo probe Sample locations - get soil 3-4 feet deep
