City of St. Louis
Board of Public Service

**MUNICIPAL RIVER TERMINAL
SEWER CONDITION ASSESSMENT**

December 14, 2012

ST. LOUIS BRIDGE CONSTRUCTION COMPANY

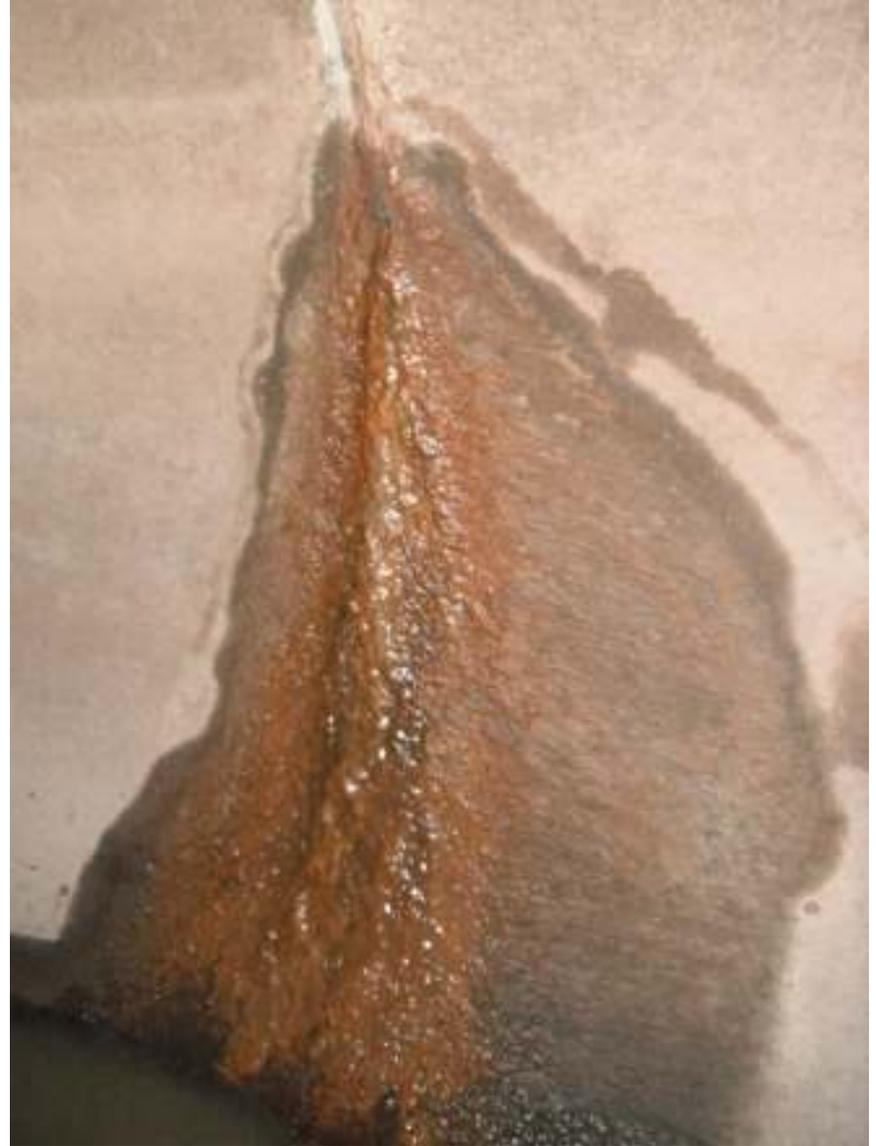
DSCF0118

0+71		Minor offset joints, Water leak and deposits through joints.		118 , 119
1+00		General condition of pipe looking downstream		120
1+50		General condition of pipe looking downstream		121
1+80		Manhole	12:00	122
2+00		General condition of pipe looking downstream, Pipe bends to left		123
2+25		Pipe bend		
2+50		General condition of pipe looking downstream		124
3+00		General condition of pipe looking downstream		125
3+50		General condition of pipe looking downstream		126
4+00		General condition of pipe looking downstream		127
4+35		End of 60in pipe looking upstream		128
		Looking downstream at outfall from access structure		129

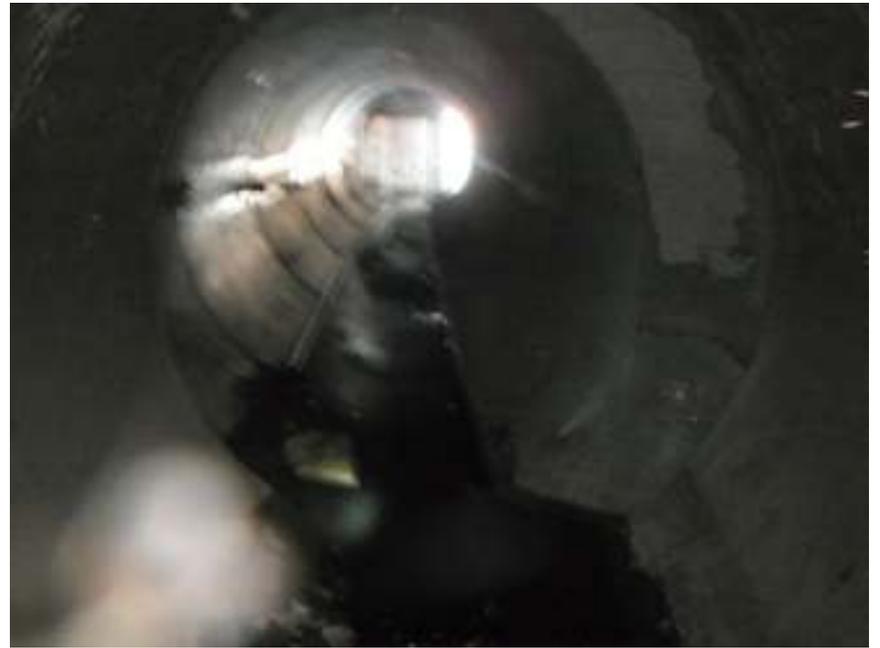
DSCF0139

2+00		General condition of pipe looking downstream		137
2+05		24" incoming pipe, MH 4ft upstream of pipe with outside drop	3:00	138
2+50		General condition of pipe looking downstream		139
2+60		End of old RCP pipe, New RCP pipe offset 1ft to left		140
3+00		General condition of pipe looking downstream		141
3+08		End of RCP pipe. Transition to RCP box, Looking upstream.		142
		Looking downstream at outfall from access structure		143

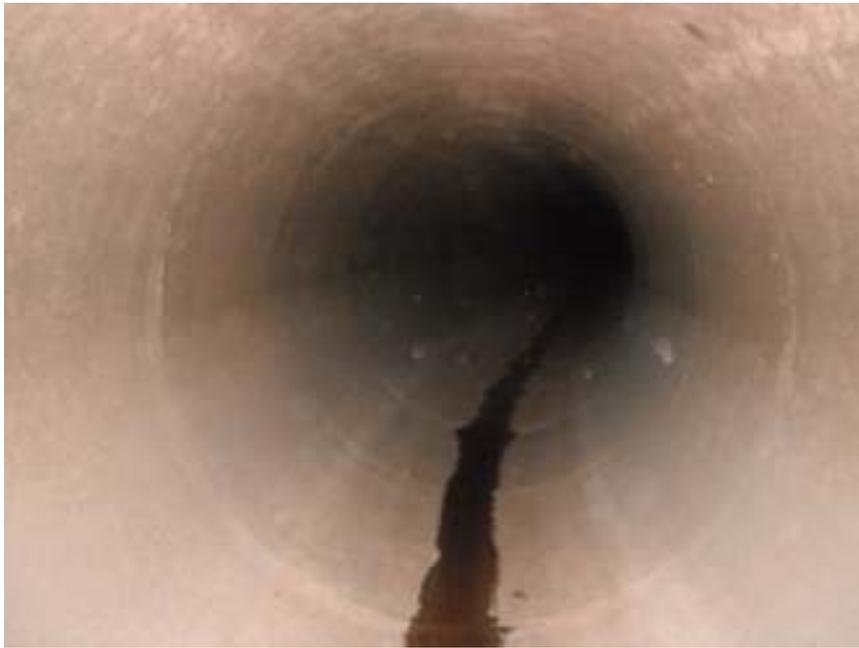
DSCF0170

Date : <u>November 9, 2012</u>		Inspection Reach (Madison Chambers Pressure Sewer)		
Inspection Team: SM, SH		Structure : <u>18D3-145C</u>	→	Structure : <u>18D3-090C</u>
Upstream MH Depth	<u>35.8 ft</u>	Project Sewer : <u>Madison Chambers Pressure</u> Shape : <u>Circular</u>		
		Location: <u>Madison St / Floodwall</u> Size : <u>60 in</u>		
Downstream MH Depth	<u>NA</u>	Length : _____ Type: <u>RCP</u>		
Notes: Entry through backflow prevention structure 18D3-182C Pipe in good condition		Weather Condition: Sunny		
Station	Defect	Description	Position	Photo
		Looking downstream at 48" RCP from backflow prevention structure 18D3-182C		160
		Looking upstream at 48" from fore bay		161
		7'W x 5.5' H Concrete box, 9ft long from fore bay to 60in pipe		162
		Transition from concrete box to 60in pipe		167
0+00		60in RCP pipe begins		
0+43		Pipe bends to right		170
0+50		General condition of pipe looking downstream		171

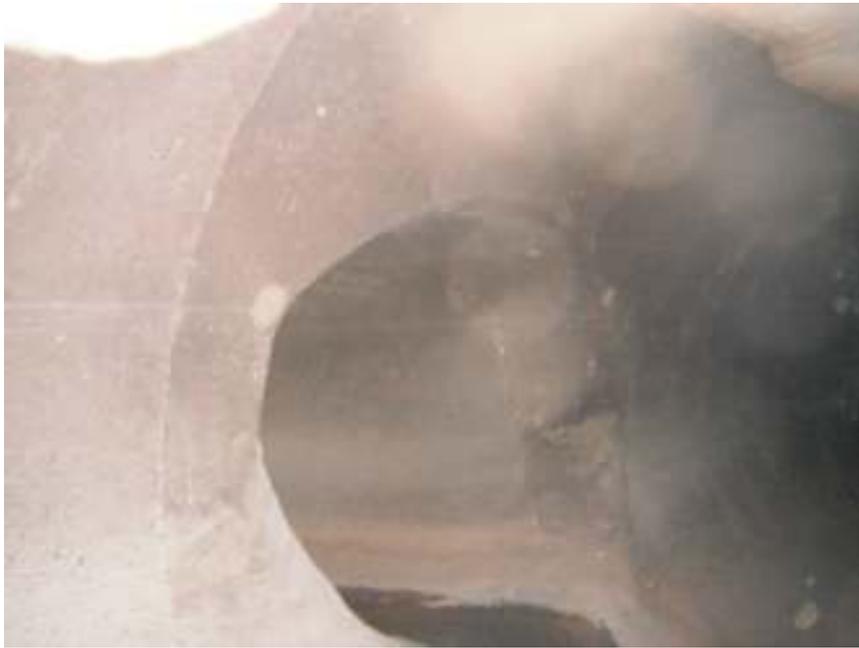
DSCF0177

1+00		General condition of pipe looking downstream		172
1+25		Pipes bends left		
1+50		General condition of pipe looking downstream		173
1+98		Junction Chamber		177

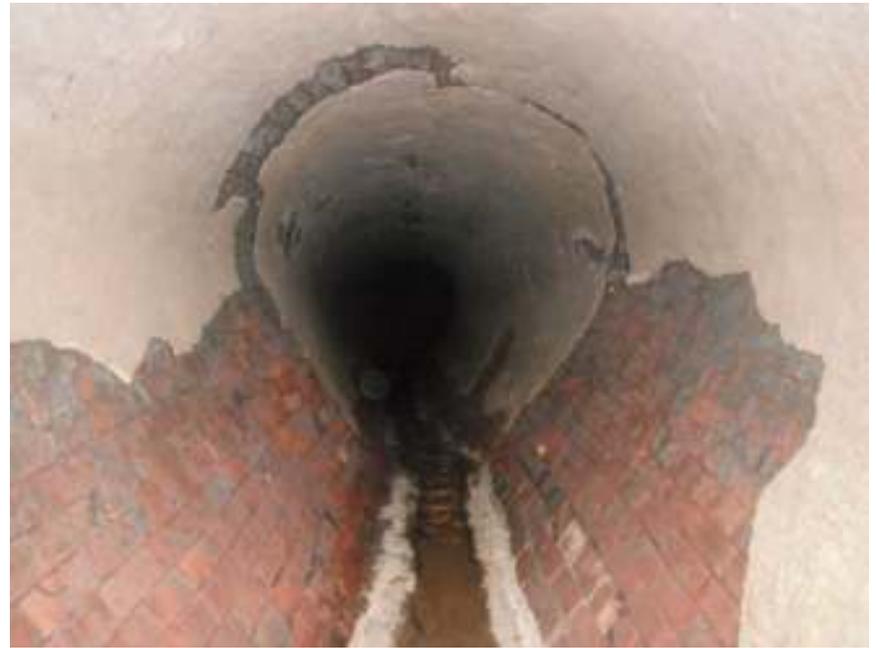
DSCF0219

1+00 - 1+15		Missing gunite lining		
1+15		Missing bricks	9:00, 3:00	220 , 221
1+35		Pipe turns right		222
1+50		General condition of pipe looking downstream		223
1+68		6in Drop in pipe invert		
1+75		General condition of pipe looking downstream		224
2+06		Pipe transition to RCP box 48" W x 60" H ,		
2+18		4" deep hole in concrete wall	3:00	227
2+27		Minor crack in vertical walls		229 , 230
