**CULTURAL RESOURCES OFFICE
 PRESERVATION BOARD
 REGULAR MEETING
 MONDAY SEPTEMBER 22, 2014 — 4:00 P.M.
 1520 MARKET ST. #2000
 ST. LOUIS, MISSOURI 63103
www.stlouis-mo.gov/cultural-resources**

DATE: September 22, 2014
ADDRESS: 2124 Victor Street
ITEM: Appeal of Director's Denial to replace a slate roof
JURISDICTION: Benton Park Local Historic District — Ward 9
STAFF: Andrea Gagen, Preservation Planner, Cultural Resources Office

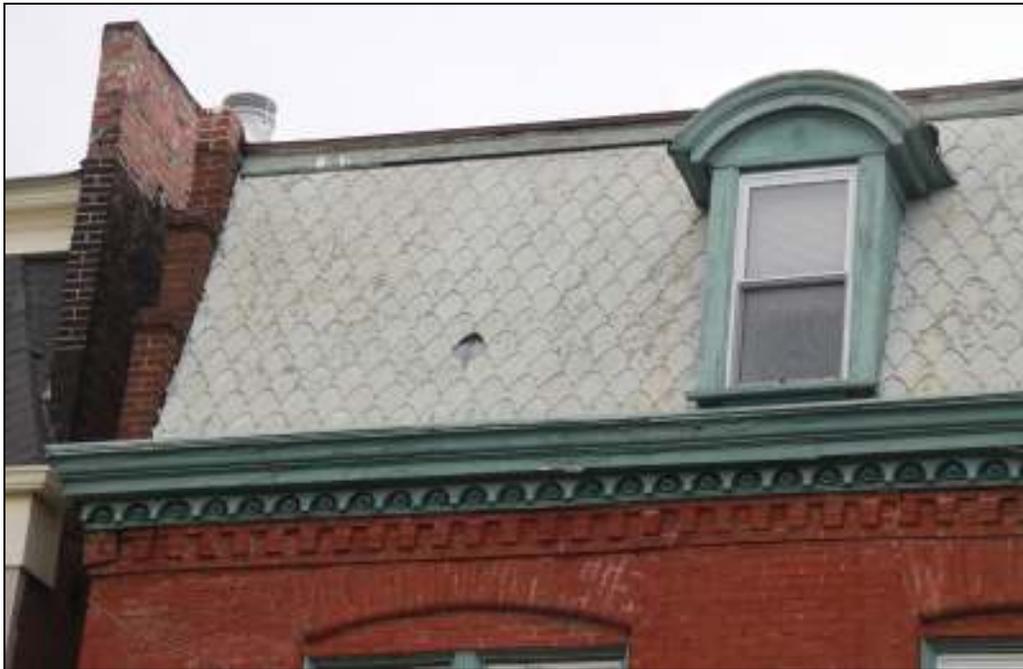
DETAIL OF SHAPED SLATES – NOTE RELATION OF SHINGLE SHAPE TO DORMER AND CORNICE DETAILS

3. Patterns on Mansard Roofs:
 1. Patterns created by the arrangement of slate of differing colors or configurations shall not be altered by the subtraction or addition of shingles;
 2. Patterns may be painted where no pattern existed originally based on a Model Example.
 3. Reconstructed mansard roofs may be patterned through the use of slate or synthetic slate shingles of differing colors or configurations. Such patterns shall be based on a Model Example.
Does not comply. The change from the distinctive shaped slate tiles to a simple rectangular shape would be a significant alteration to the roof configuration.

- 2124 Victor is located in the Benton Park Local Historic District.
- The applicant is proposing to replace shaped slate shingles with typical rectangular slate shingles which would present a quite different appearance than patterned slate.
- The shape of the slate shingles is a character-defining element of the historic building. The arched pattern is consistent with the arched dormer roofs and the unusual arcaded detail of the building cornice. Changing the shape of the shingles would be a significant alteration to the building's design.
- Slate in this configuration would be available from a roofing contractor or someone who specializes in slate who would have to cut each slate.

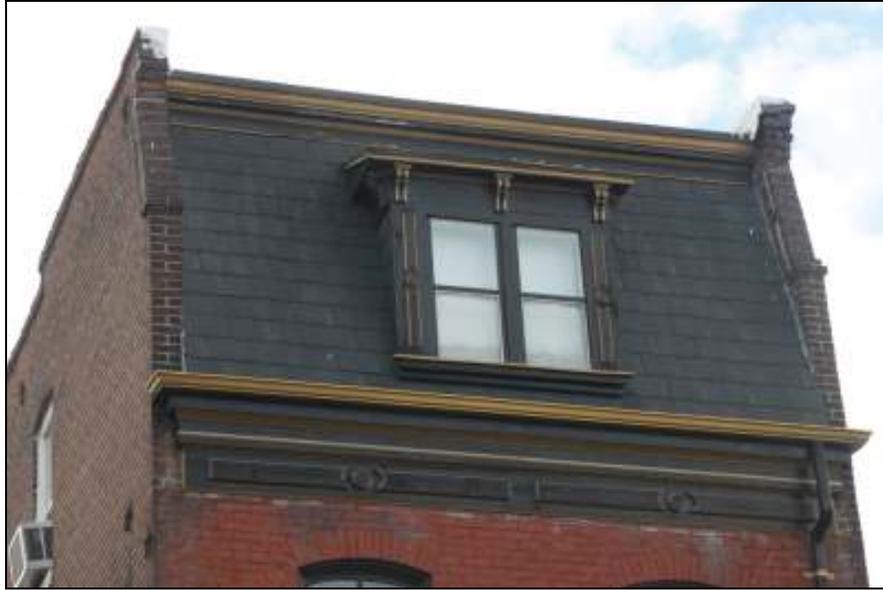
MANSARD WITH RECTANGULAR SLATE

The applicant has a building permit application to install a replacement slate roof on a mansard and repair woodwork. The applicant proposes to replace the distinctively shaped slate tiles with rectangular slate. The permit application was denied as the change in configuration of the slate tiles does not meet the Benton Park historic district standards.

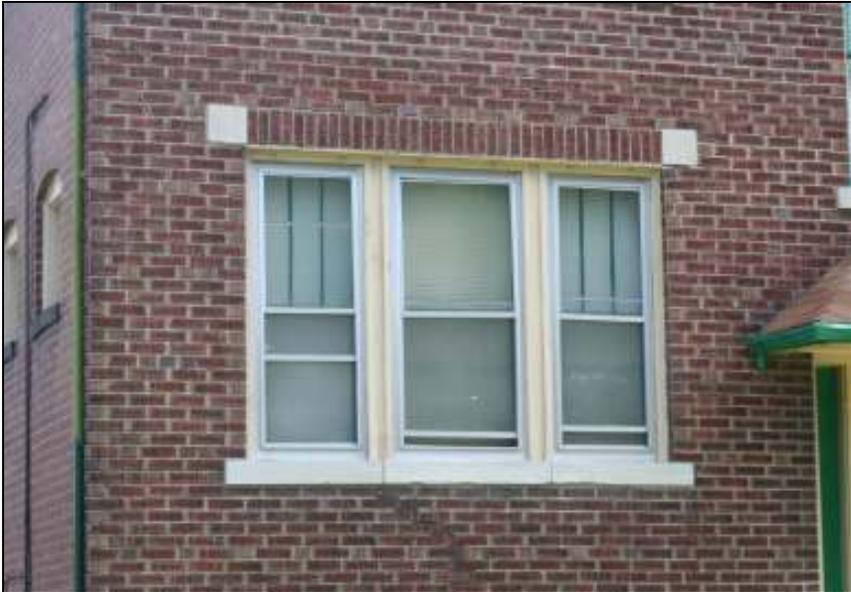
DETAIL OF ORIGINAL WINDOWS (BEHIND ALUMINUM STORM SASH)

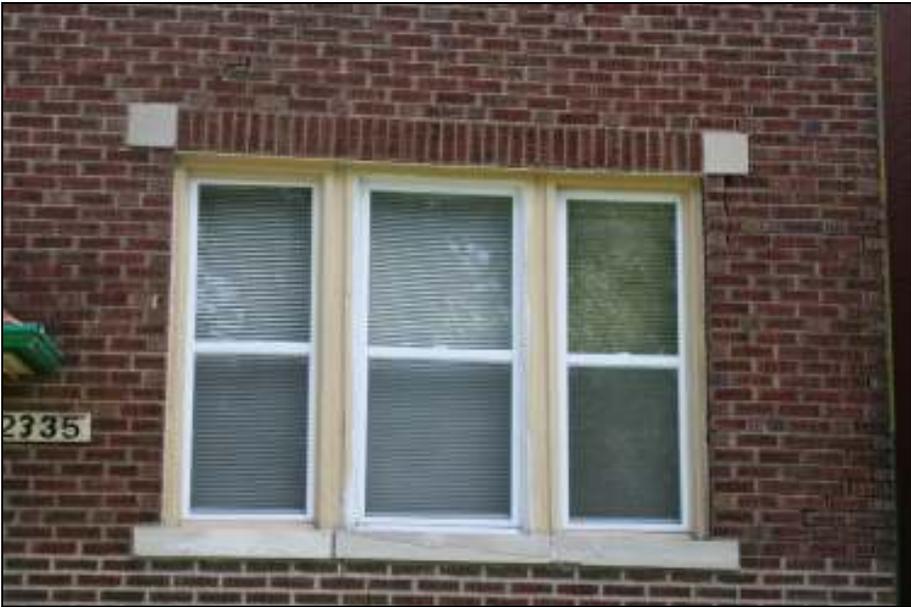
REPLACEMENT WINDOWS

Does not comply. The windows installed on the public façade are made of vinyl, a material that does not comply with the Standards. The windows do not replicate the original as the sashes have uniformed sized rails and do not replicate the dimension of historic wood windows. The original windows had a three-over-one muntin configuration; the replacement windows have no muntins. The new windows present a flat appearance and do not convey the depth shown in the offset sashes of historic windows.

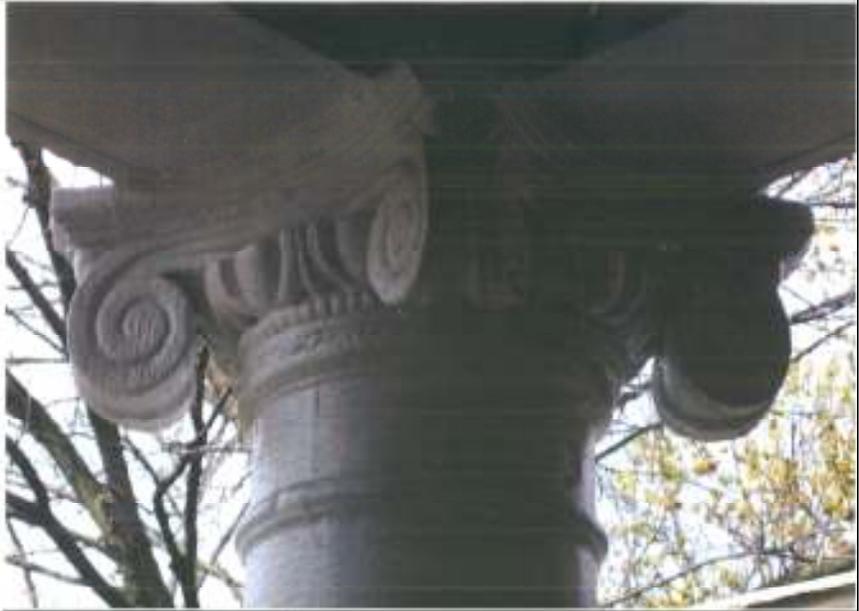
EXISTING COLUMN CAP
18-1/4" WIDE
7" TALL

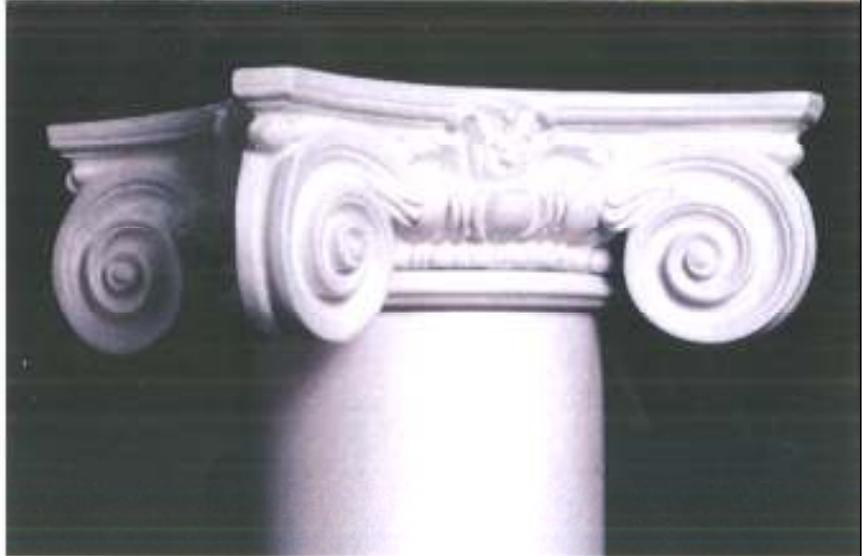
NEW COLUMN CAP
16-5/8" WIDE
5-1/16" TALL

- The wood columns have been examined in the field and need only cosmetic maintenance to remain in service.
- The proposed replacement fiberglass columns and capitals do not do not replicate the existing elements. The capitals are smaller in size than the original, of a different material and do not have the same design as the original. The new columns do not have the ornamentation at the neck or the same entasis as the original columns.

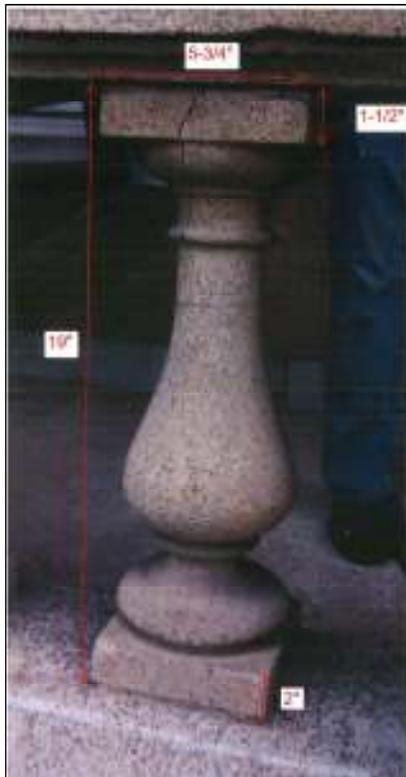
DETAIL OF EXISTING BALUSTERS

The Cultural Resources Office inspected the site and confirmed that the cast concrete balusters were cracked and spalled and not salvageable. The applicants propose fiberglass balusters that are close in size and fairly close in detail to the existing balusters, and a handrail will be similar in size but not in profile. The staff acknowledges that both these replacement elements are about as close to the balustrade's original appearance as could be found without re-casting the historic elements. However, the existing wood columns above the cast-concrete posts are undamaged and carry very elaborate Ionic capitals. The staff suggested that in

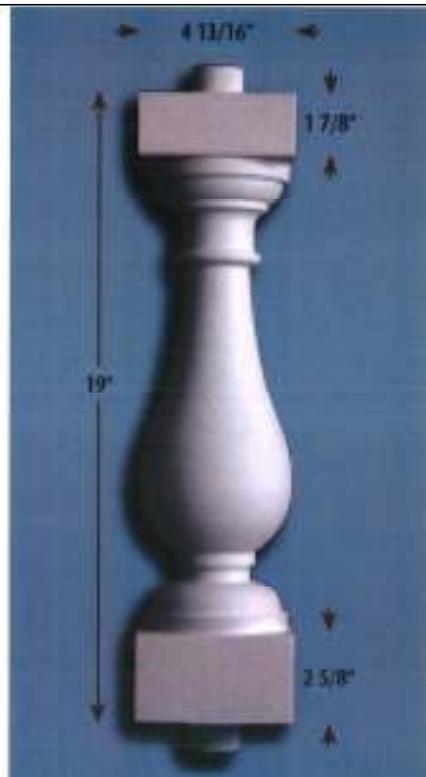
EXISTING BALUSTER

PROPOSED BALUSTER

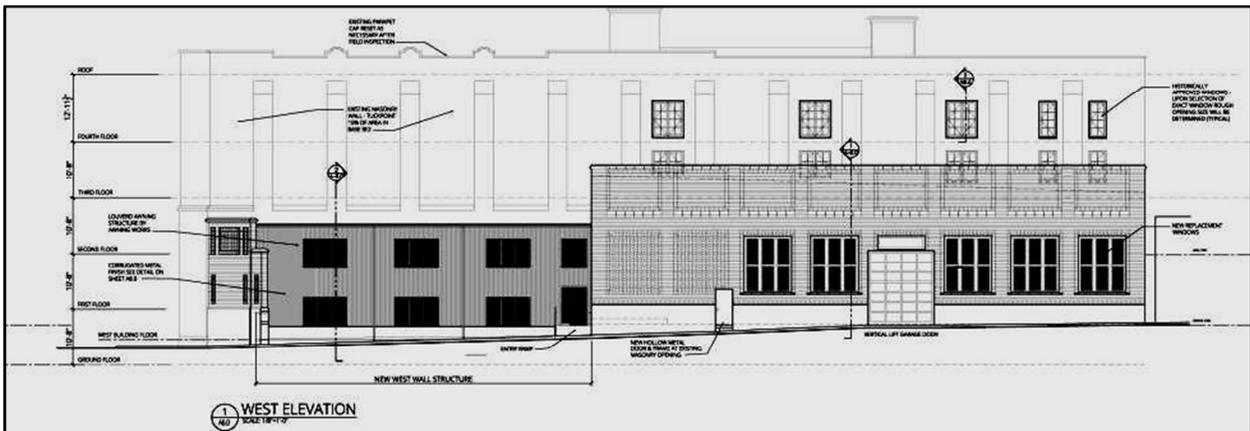
PROPOSED WEST ELEVATION

Based on these preliminary findings, the Cultural Resources Office recommends that the Preservation Board overturn the Director’s denial of the application based upon the revised west elevation, and subject to the condition that final plans and exterior materials will be reviewed and approved by the Cultural Resources Office.

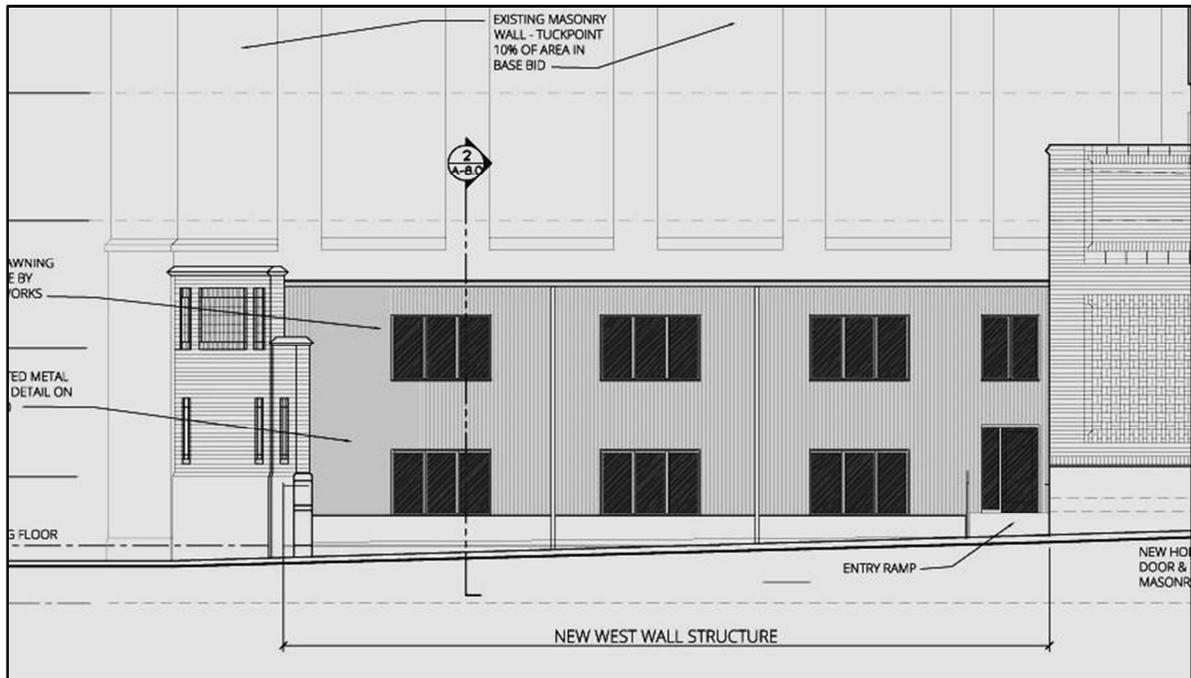
DETAIL OF ADDITION

Does not comply. The reconstructed wall at the loading dock area, along with a new roof, will enclose occupied space. Remnants of the original wall of the loading dock enclosure at this location show that it was brick. The reconstructed wall is proposed to be faced with corrugated sheet metal. In discussion with the project architect, it was found that adding brick to this elevation would add approximately \$12,000 to the costs of the project. The corrugated sheet metal is a material associated with industrial buildings and may be appropriate for this property. The architect has agreed that the metal will be dark gray and have a matte finish.

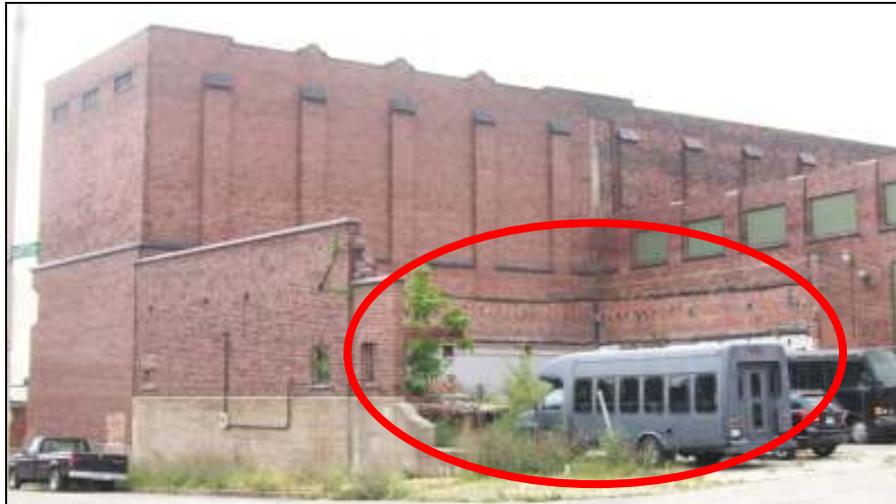
LOCATION OF ADDITION/RECONSTRUCTED AREA

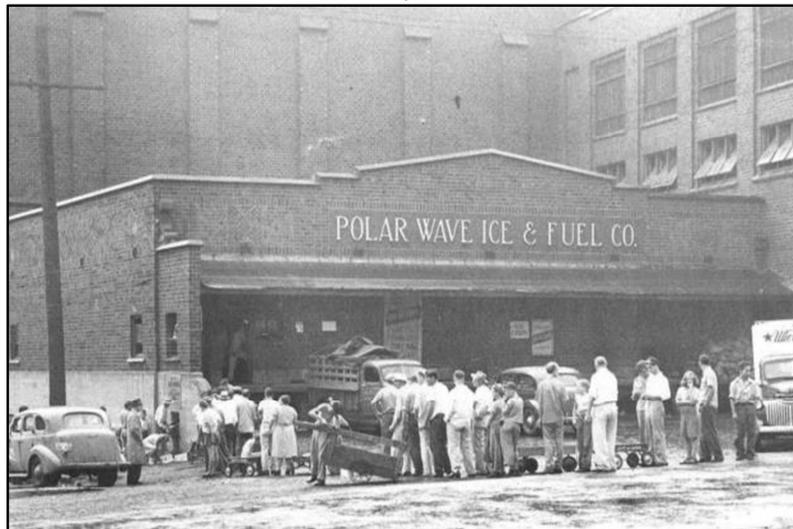
HISTORIC PHOTO OF ORIGINAL LOADING DOCK

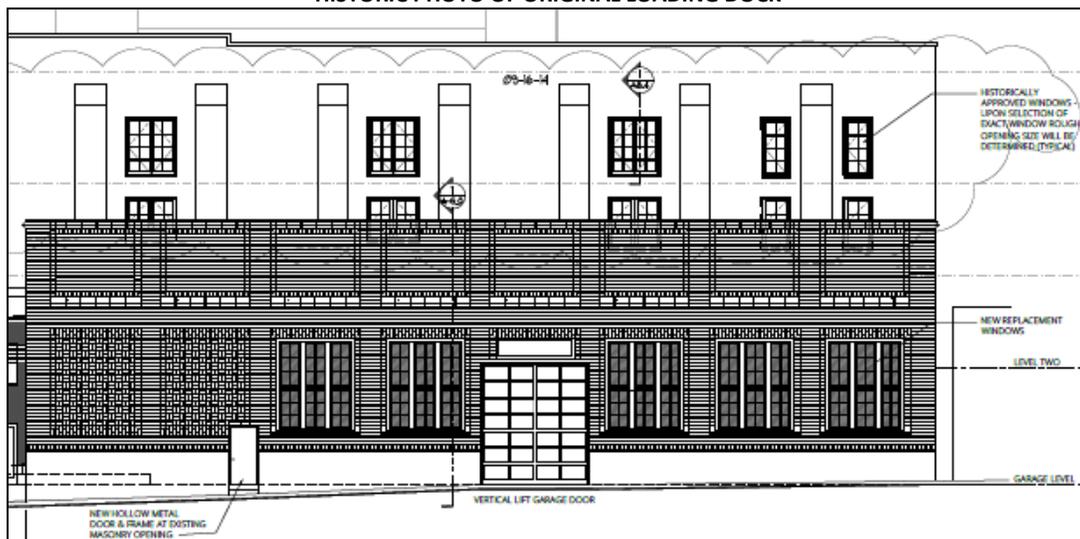
PROPOSED WINDOW OPENINGS AT 3RD & 4TH STORIES

The appellant applied for a permit for interior and exterior remodeling. The project requires new window openings to be cut into the building. Originally the window openings were to be on the alley (east) façade, a Private Façade under the definition of the Soulard Standards, but the National Park Service, reviewing the project under the Federal Historic Tax Credit program, requested that some of the openings be moved to the west façade, which is a Public Façade. The appellant is also reconstructing the loading dock area on the 9th Street elevation with a corrugated metal façade and large triple windows. The permit was denied as the proposed windows and design of the reconstructed loading dock area do not comply with the Soulard Historic District standards. The appellant has appealed the Director's denial.

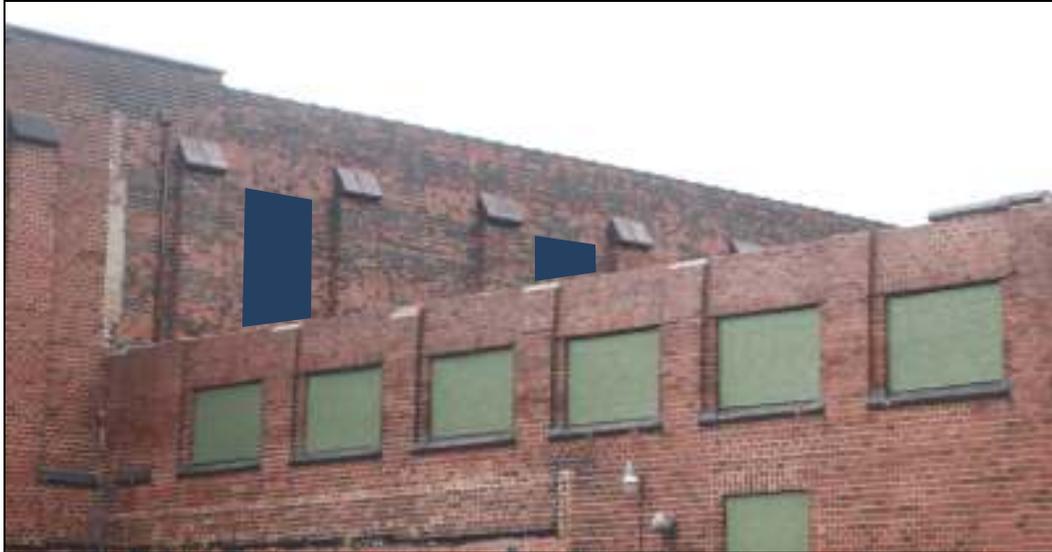
APPROXIMATE LOCATION OF NEW OPENINGS ON 9TH STREET FAÇADE
